# RPW Antenna 3 Nov. 13, 2023, Operation Anomaly Report

Ref: ROC-OPS-NMP-RPT-00158-LES  
Issue: 01  
Revision: 00  
Date: 23/04/2024

This document presents the operation report concerning the RPW electrical antenna 3 (ANT3) anomaly, first observed on-board on November 13, 2023 around 23:36z.

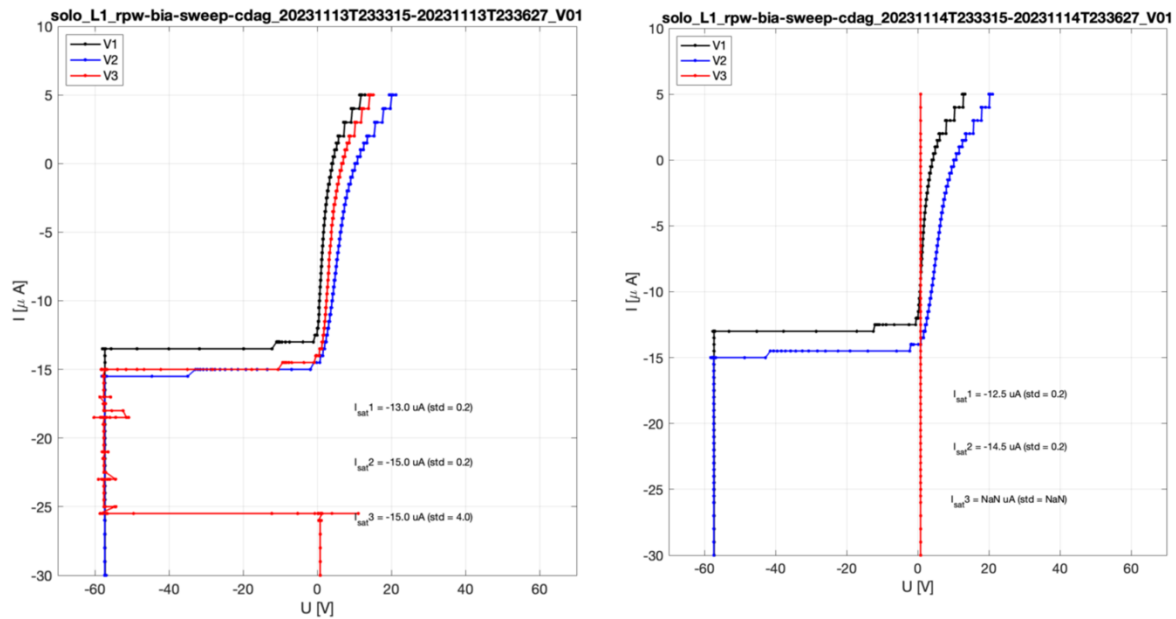
Any problem with the bias electronics is pretty much ruled out: everything works nominally when the calibration relay is flipped, that relay is the only component between the antenna and the parts that work perfectly, and a relay issue can hardly cause a short. This leads to exclude the Bias electronics as a possible origin of the anomaly.

Figure 1. Bias sweeps on Nov. 13, 2023 around 23:33z (left plot). Bias sweeps on Nov. 14, 2023 at the same time (right plot). On Nov. 13 plot, voltage measured on antenna 3 (red curve) promptly tends to  $\sim 0.7\text{V}$  after few minutes, which is not expected. Sweeps on the next day (and the followings) show always a  $\sim 0.7\text{V}$  vertical line for voltage measured on the antenna 3.

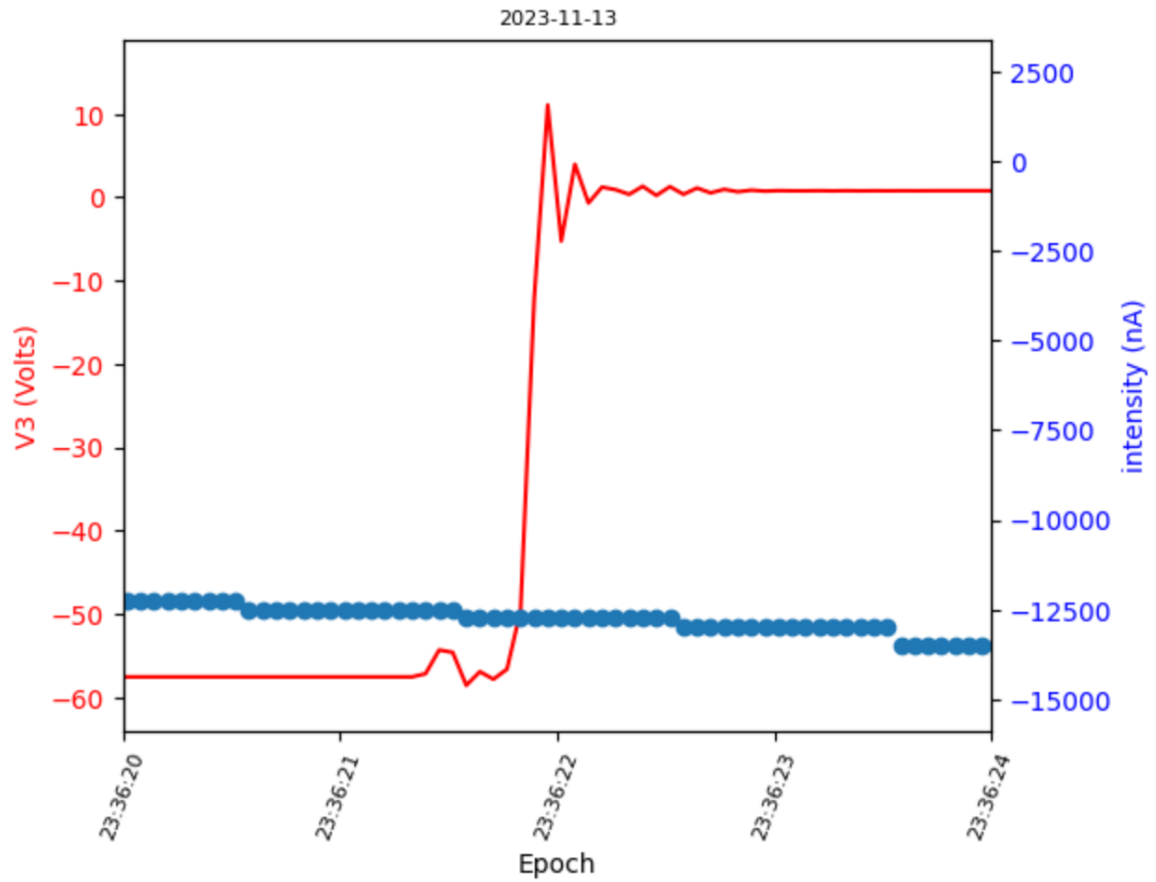
Figure 2. Potential value in Volts measured by LFR on the ANT3 (red curve) between 23:36:20z and 23:36:24z on Nov. 13, 2023. The measurements are acquired during a bias sweep; the intensity current injected in the antenna is plotted here in blue dotted. ANT3 potential brutally returns to 0V between 23:36:21z and 23:36:22z.

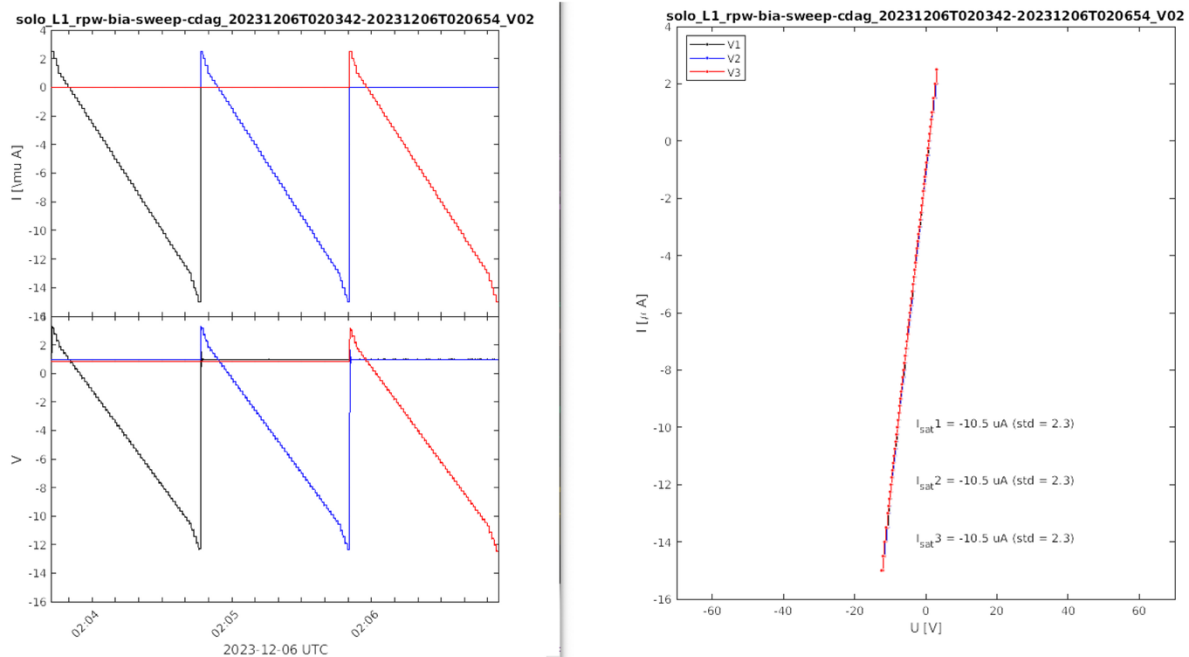
Figure 3 shows an example of time series acquired during a Bias calibration performed on-board after the anomaly (here on Dec. 6, 2023). Left plot presents the intensity current  $I$  in  $\mu\text{A}$  (top) and the LFR potential  $V$  in Volts (bottom) as a function of time, measured from the three channels 1 (black), 2 (blue) and 3 (red). Right plot gives the resulting “ $I$  versus  $V$ ” curves for the three channels from the same Bias calibration activity. During Bias calibrations, no anomaly is observed and the data are nominal.

**Figure 3.** On the left, time series of current intensities (top) in  $\mu\text{A}$  and corresponding measured LFR potential in Volts obtained during three successive Bias sweeps performed on each channel 1 (black curve), 2 (blue curve) and 3 (red curve). These bias sweeps were performed on Dec. 06, 2023 (after the incident) during an on-board calibration, when the three Bias channels are connected to the resistors and not to the three antennas. We see from plot on the right (current as a function of voltage) that three channels' curves are perfectly aligned as expected. This indicates that the problem might not come from the Bias electronics.

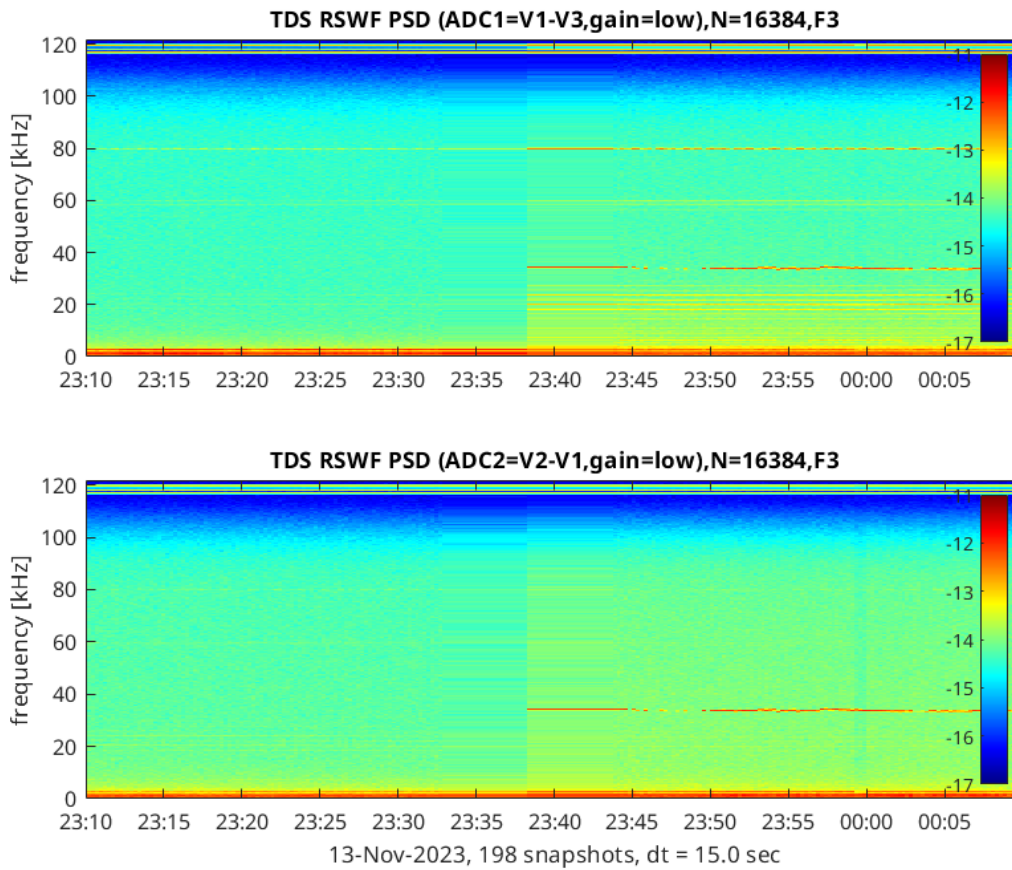
disappears while AC signals above ~20 kHz are still observed with some attenuation. This situation could correspond to a capacitive coupling between the preamplifier input and the antenna.

Figure 4. TDS E-field spectrogram around the time of the anomaly.

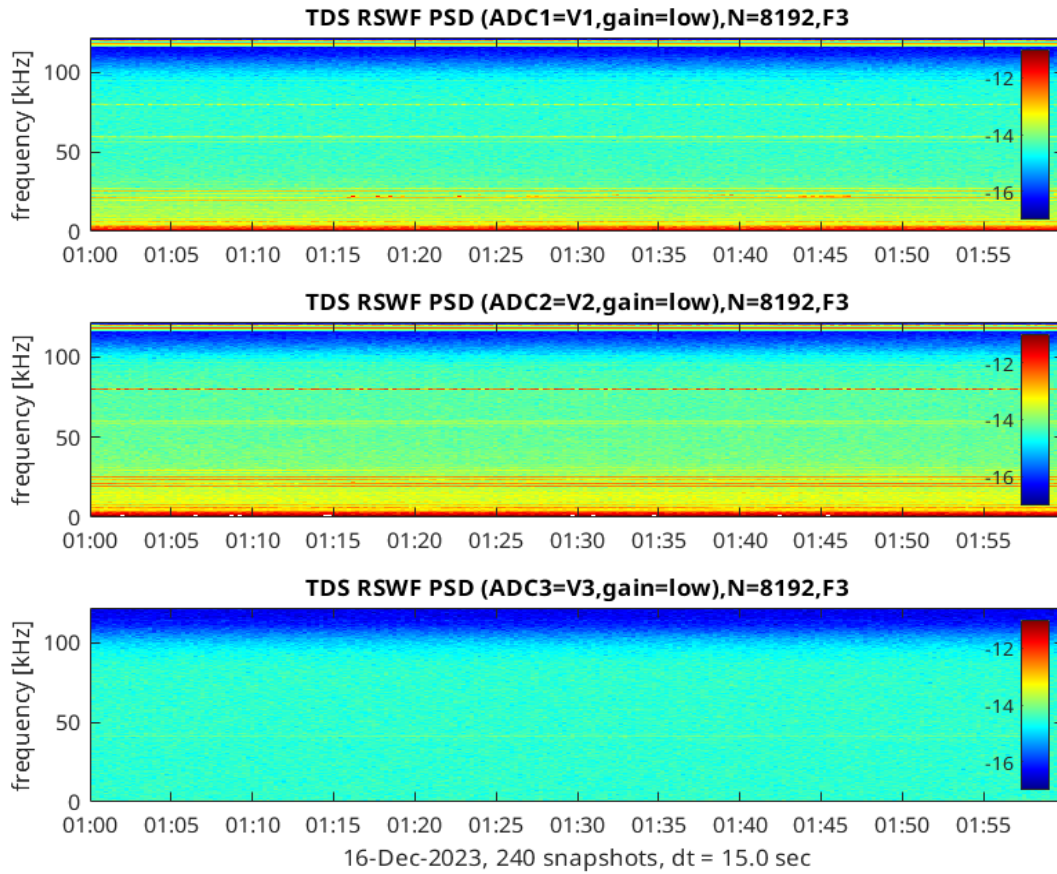
**Figure 5. TDS regular snapshot spectrogram after the anomaly, after switching to a monopole antenna configuration.**

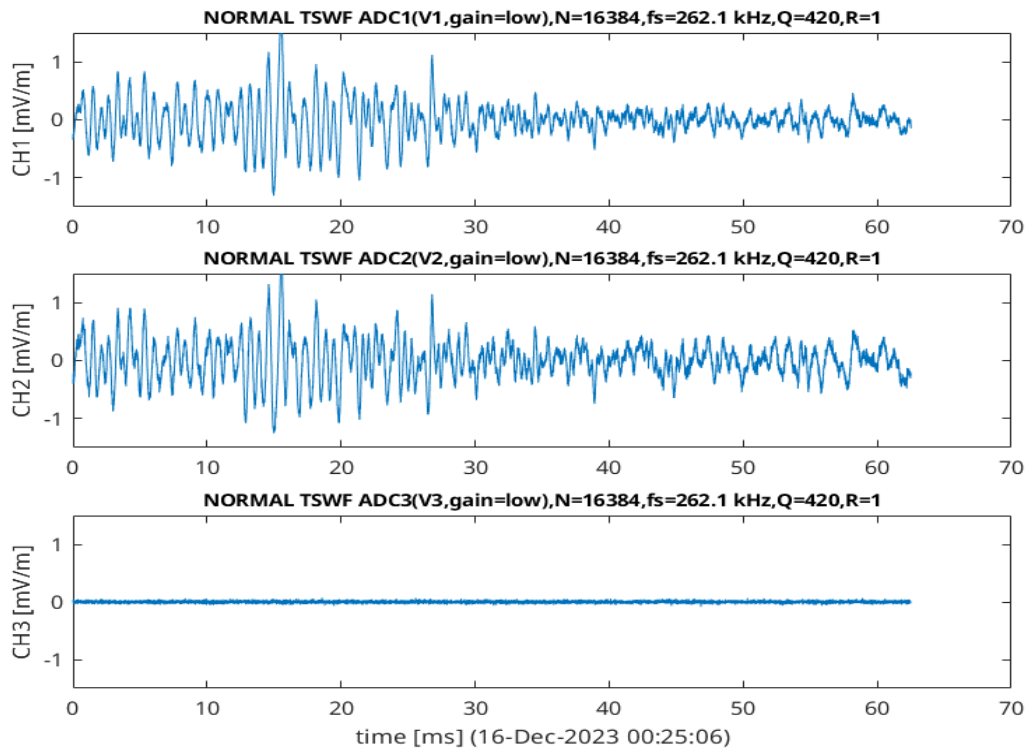
Figure 6. Example of a waveform snapshot from Dec 16, in monopole configuraiton.

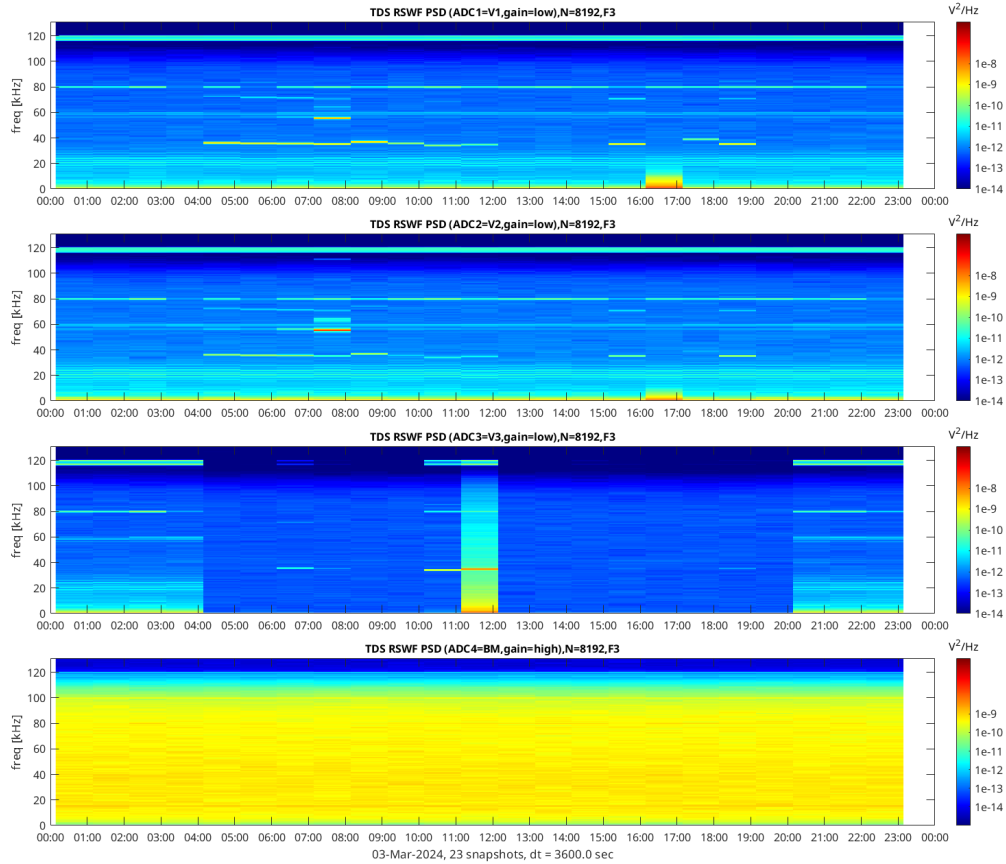
The status was unchanged until February 29<sup>th</sup>, when signal suddenly appeared again in this channel and the antenna seemed to operate normally and provide good data. Since then, however, we have observed several occurrences of a temporary re-occurrence of the anomaly – on March 3, March 9, 10, 11. Except for March 3, the anomaly usually re-appears after a BIAS sweep performed around midnight and persists for several hours.

Figure 7. An intermittent re-occurrence of the anomaly on March 3rd (Regular snapshot spectrum).

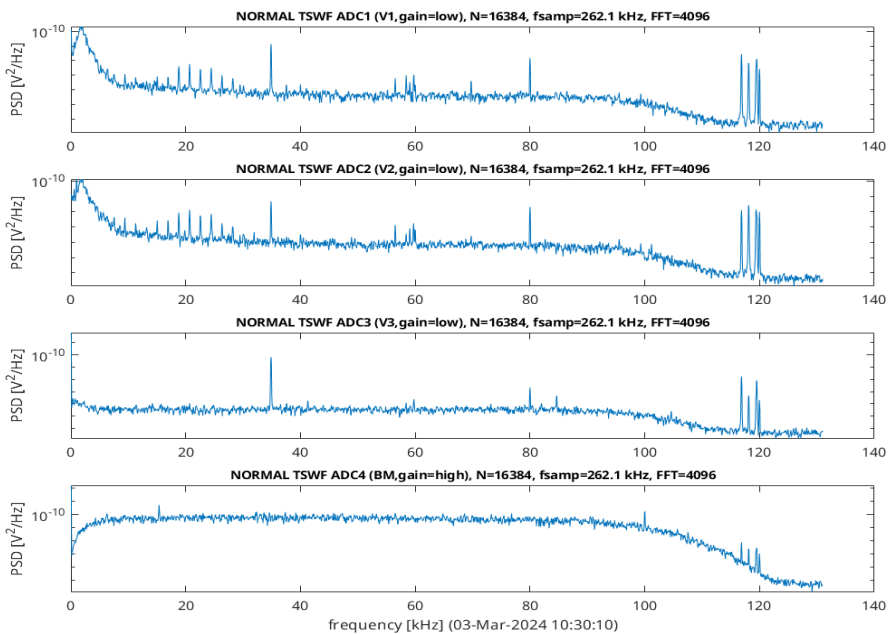
Figure 8. An examples of a detailed spectrum during the intermittent anomaly reoccurrence – there V3 antenna shows a « partial » short/disconnect.

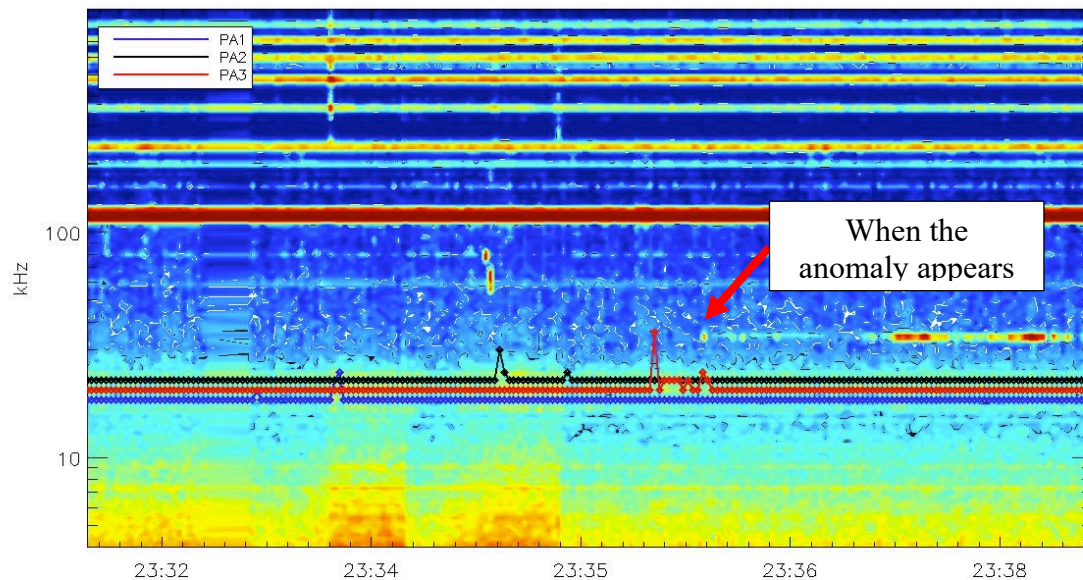
**Figure 9. Dynamical spectrum acquired by TNR in V1-V2 dipole on Nov. 13, 2023 around 23:30z. The current HK -5V values of the three PA HF 1, 2 and 3 over time are overplotted around 15 kHz.**

Note: As on the TDS spectra, we see the appearance of interference around 30 kHz after the breakdown, but we do not perceive an increase in the background on V1-V2.

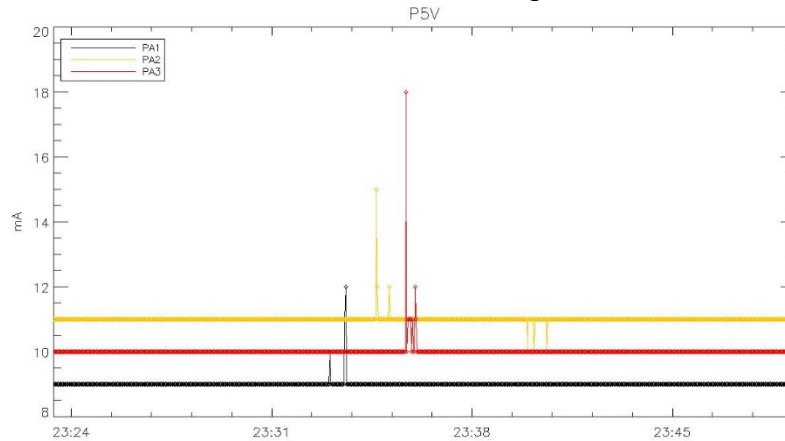
Figure 10. Current HK on the +5V of the 3 PA HF.

- Overconsumption of HF preamps is clearly observed at the precise moment when the breakdown occurs.
- This overconsumption results in more or less intense current peaks, which spread over approximately 1 min.
- The currents on the +/-5V voltages of the 3 HF preamps are very correlated, which is rather normal.
- By fluctuating from 10 to 18mA, the preamps #3 has a higher consumption peak than the other 2 preamps.
- Consumption transients of this type have already been observed at other times but not with such intensity (see [RD2]).
- Consumption always ends up returning to its original level (~10mA)

The origin of these consumption peaks seems to coincide with the high voltage (HV) sweep (+/- 60V) of BIAS. They are not a priori caused by external events; e.g. impacts of charged particles on the antennas.

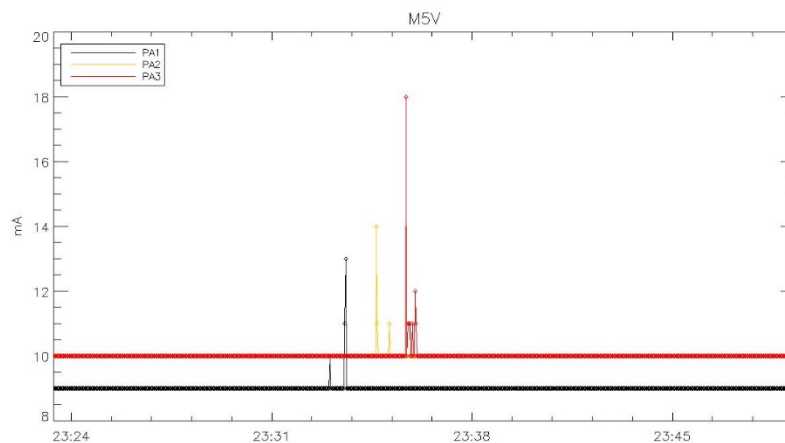
Figure 11. Current HK on the -5V of the 3 PA HF.

The consumption returns to its original level. This suggests that the HF preamps are not damaged and in good health (this is a necessary condition but may be not sufficient).

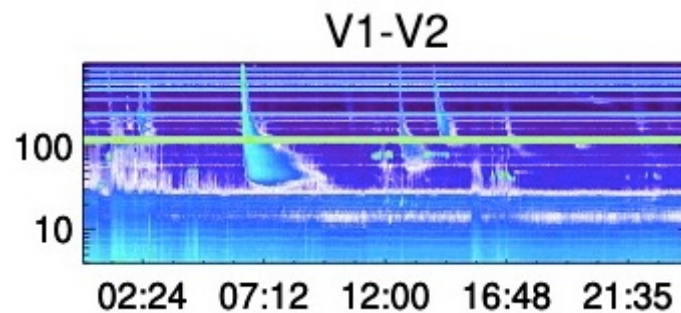
Type III signals were observed after the breakdown. These are characterized by broadband emissions whose spectrum changes over time. They cover practically the entire range of TNR BCD bands (16 kHz to 1 MHz); which allows us to see the behavior of the instrument over a relatively wide spectral range.

Figure 12. Dynamical spectrum acquired by TNR in V1-V2 dipole on Jan. 22, 2024.

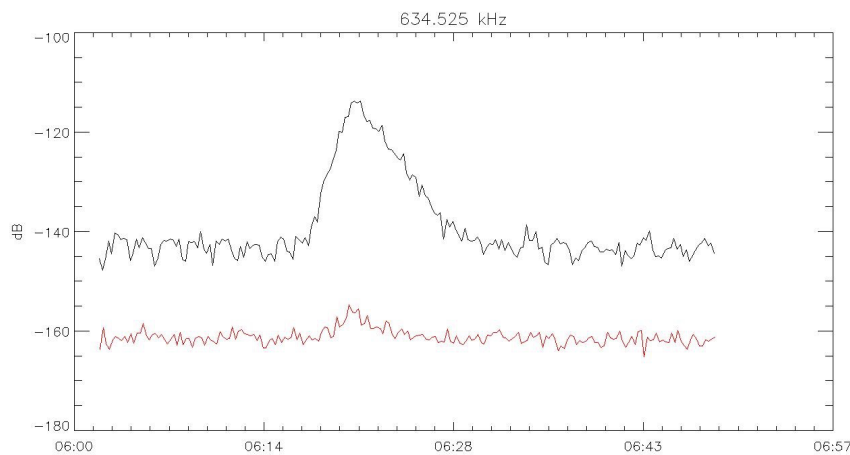
Figure 13. Type III observed on the TNR at 634.525 kHz (V1-V2 in black and V3 in red).

This observation shows that the signal on V3 is attenuated by around 40 dB compared to that measured on V1-V2. It is very weak but it does exist and this is not due to crosstalk because

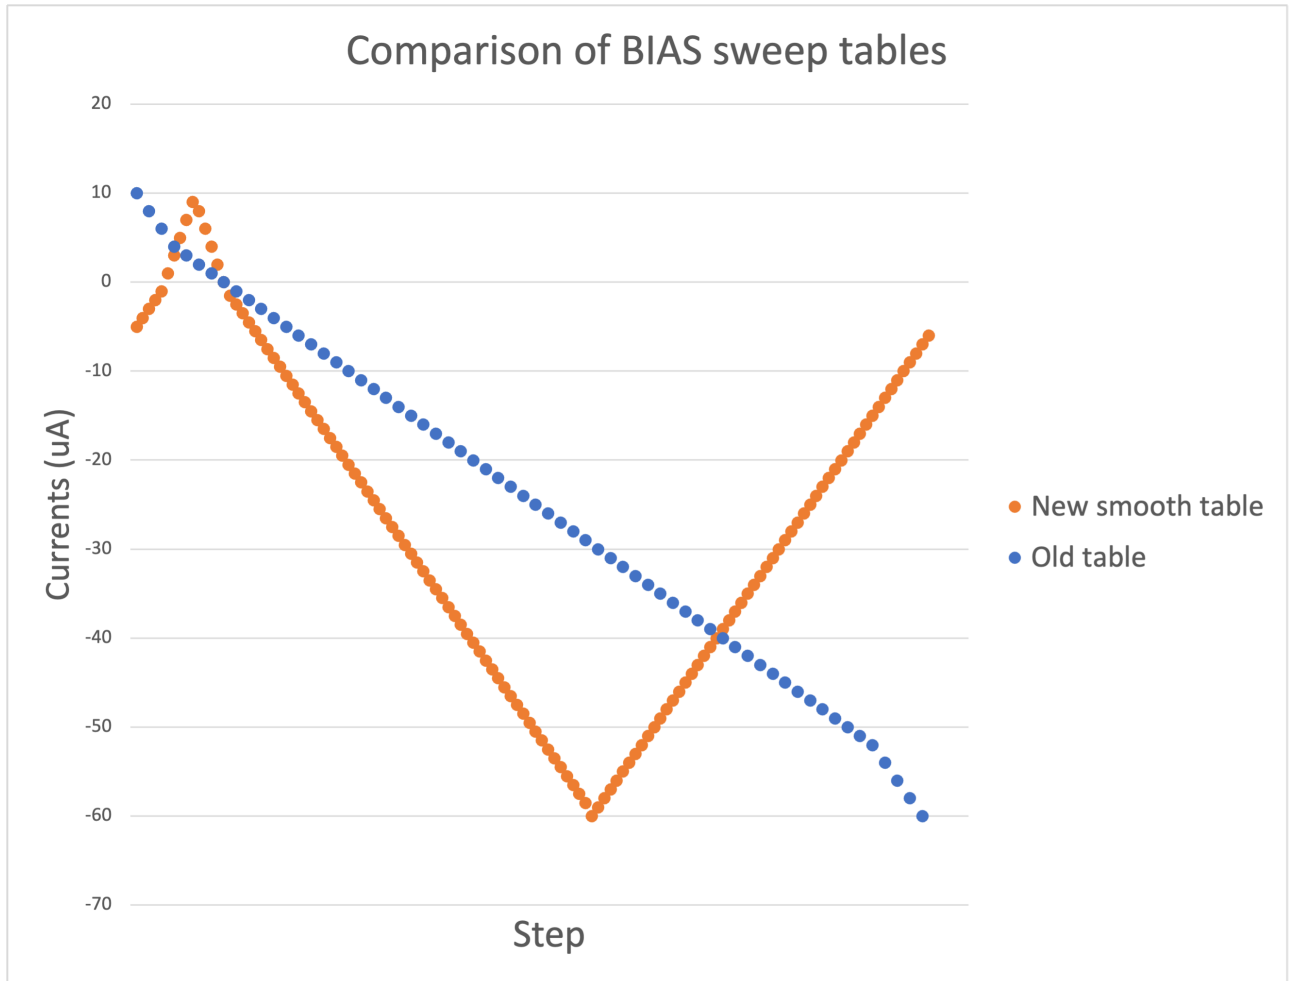
**Figure 14. New Bias sweep table current values (orange dot) to be applied on-board to mitigate the HF PA latch-up during sweeps. Old table is plotted with blue dots.**

- Use a new “smoother” Bias sweep table values (see figure below) to limit the risk of damage for the HF PA (see section 3.2.5). The TC sequence required to load new Bias sweep table with TC\_LOAD\_BIAS\_SWEEP {ZIW00060} command is in preparation.

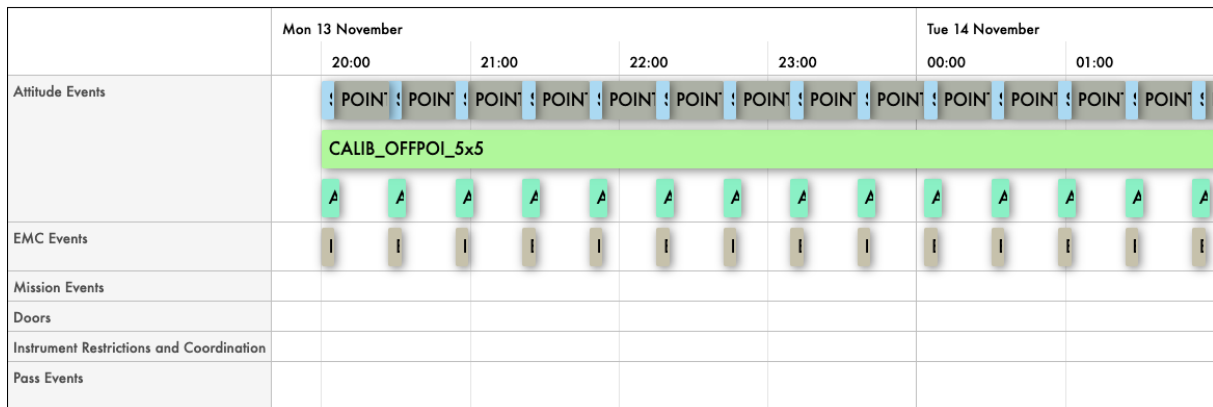
Figure below shows a extract of the E-FECS planning from the SoopKitchen tool for the LTP13. Attitude disturbance (SLEW) was run between 23:36:00z and 23:41:00z when the anomaly occurred.

Figure 15. Mission level planning around Nov. 13, 2023 at 23:30z. (Extracted from LTP13\_Sep2023-Dec2023 SoopKitchen plan). During this period, several attitude events were schedules: SLEW (in blue), POINT\_PATTERN (in grey) and CALIB\_OFFPOI\_5x5.

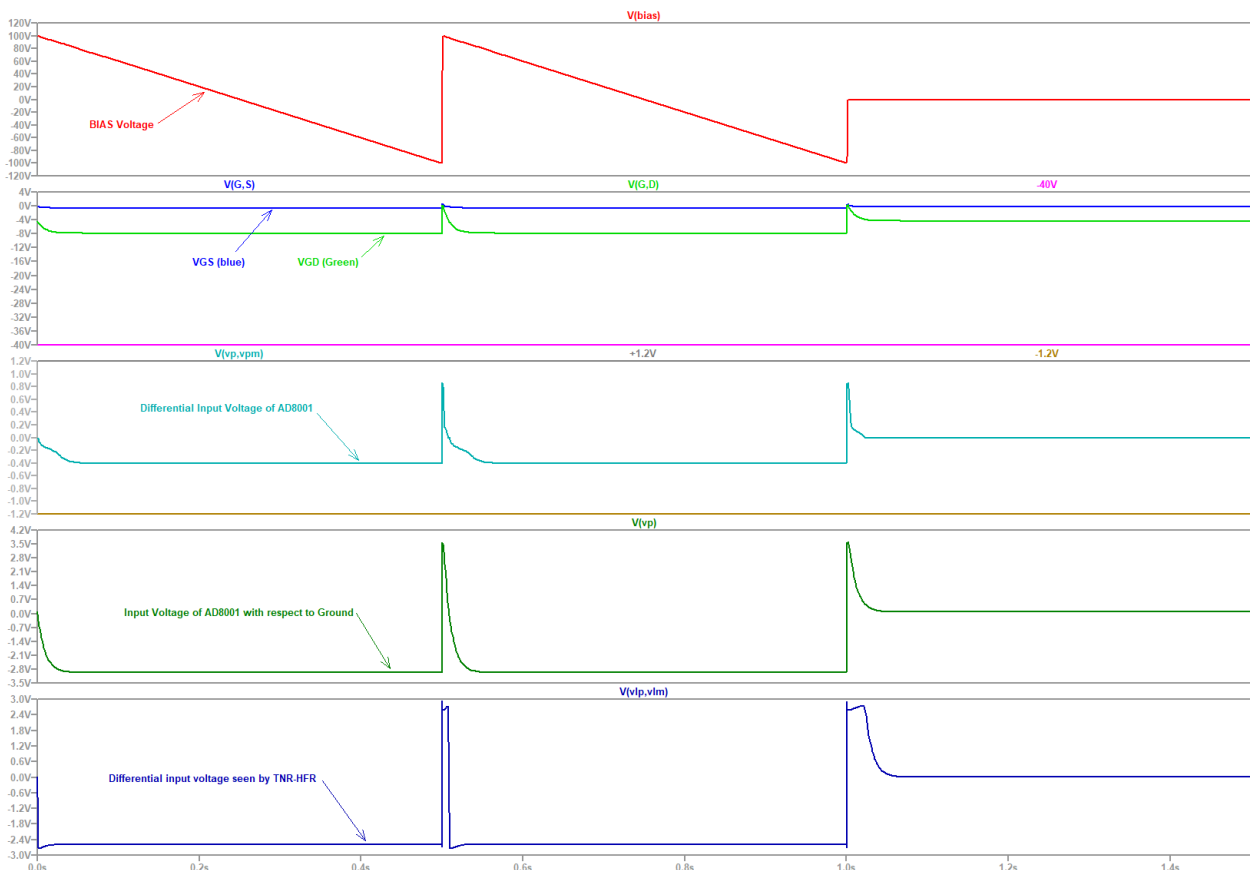
Figure 18. Responses of different intermediate signals from the HF PA.

3. The waveform at the output of the preamps (differential signal in blue) shows a relatively narrow and intense pulse. This coincides with the rising edge of the BIAS sweep, which has the effect of saturating the HF preamp for a short duration. This voltage pulse results in excess consumption in the 110 ohms load, which explains the current peaks observed on the monitoring HKs.

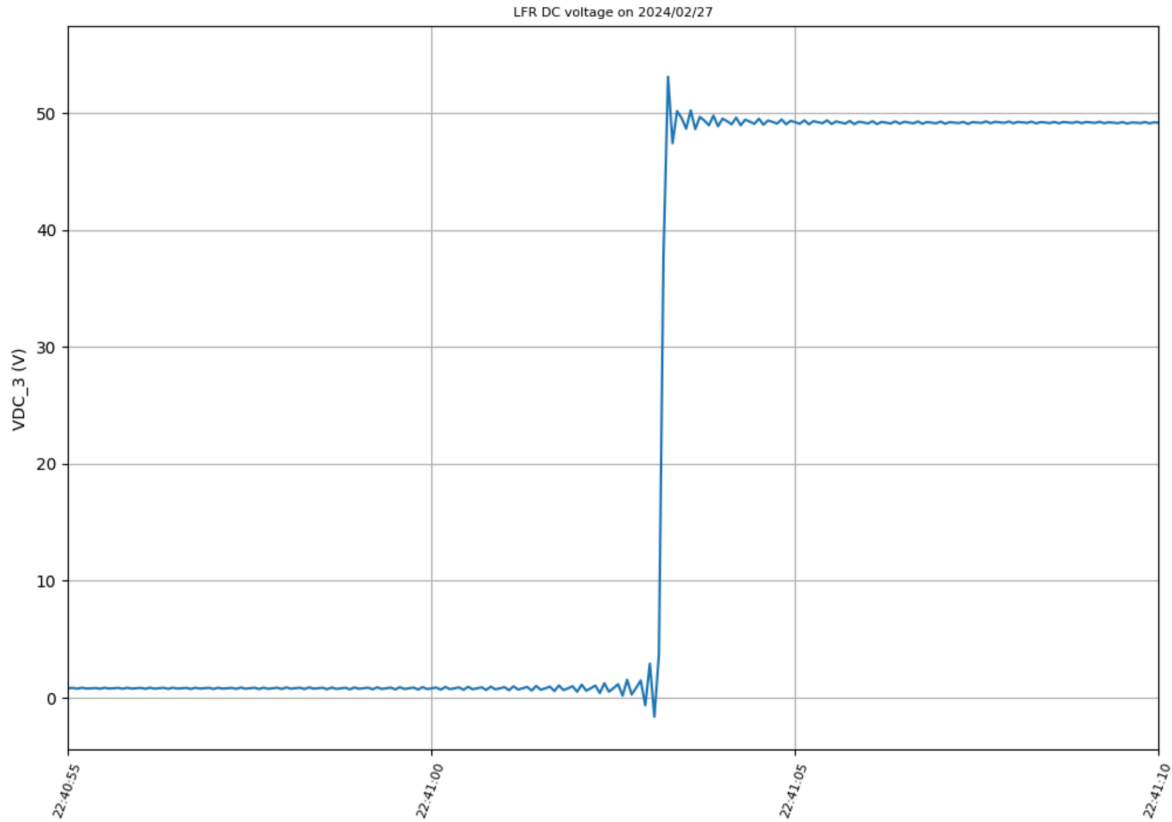
**Figure 19. LFR CWF DC voltage measured on Feb. 27, 2024 between 22:40 and 22:41.**

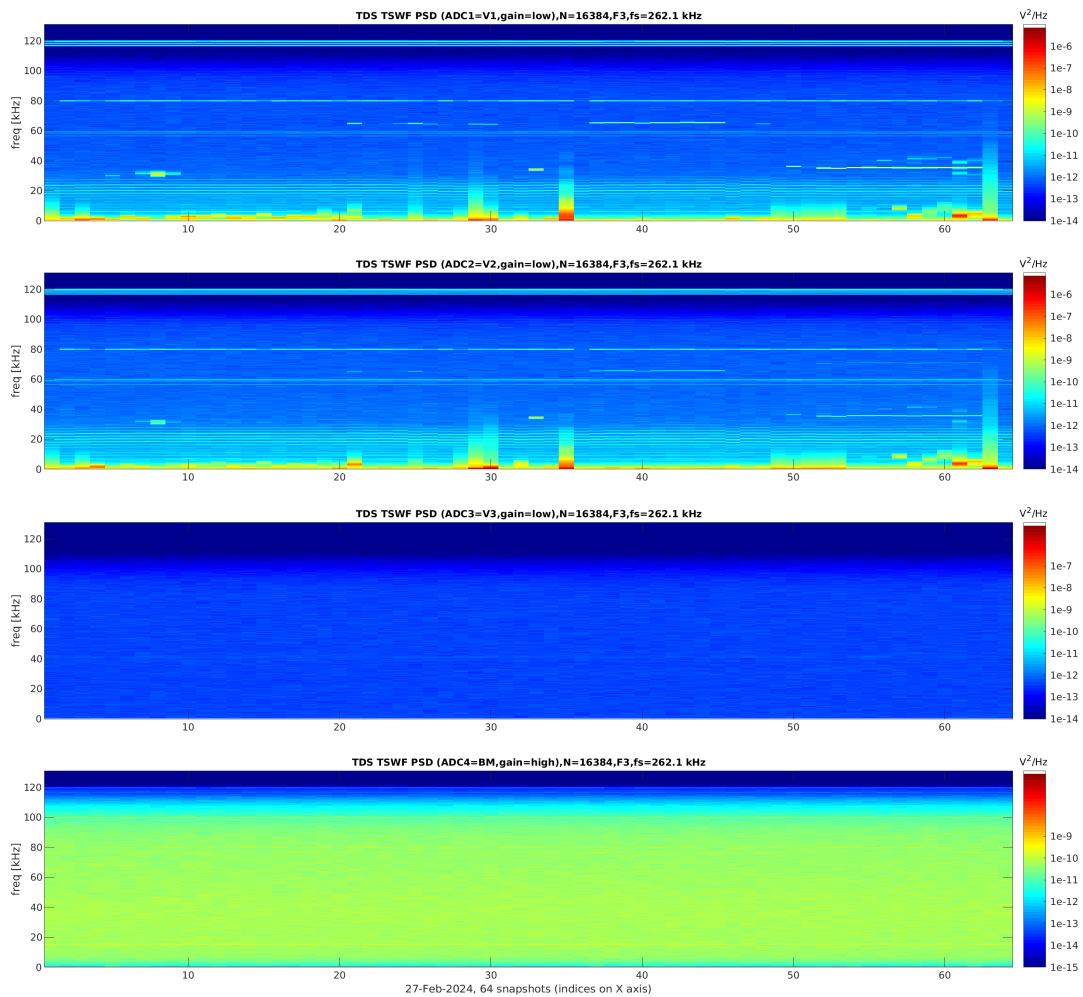
This event was also confirmed by TDS. Figures below show TDS E-field spectrograms obtained from TSWF data acquired on-board on February 27<sup>th</sup> (Figure 20) and 28<sup>th</sup> (Figure 21) of 2024 respectively. V3 channel (third spectrogram from the top on each figure) shows no signal on Feb. 27, but is come back the next day. On TDS, the time resolution was too low to determinate the time of the event with accuracy.

Figure 20. TDS E-field spectrograms from TSWF data acquired on Feb. 27th 2024. V3 channel is the third from the top.

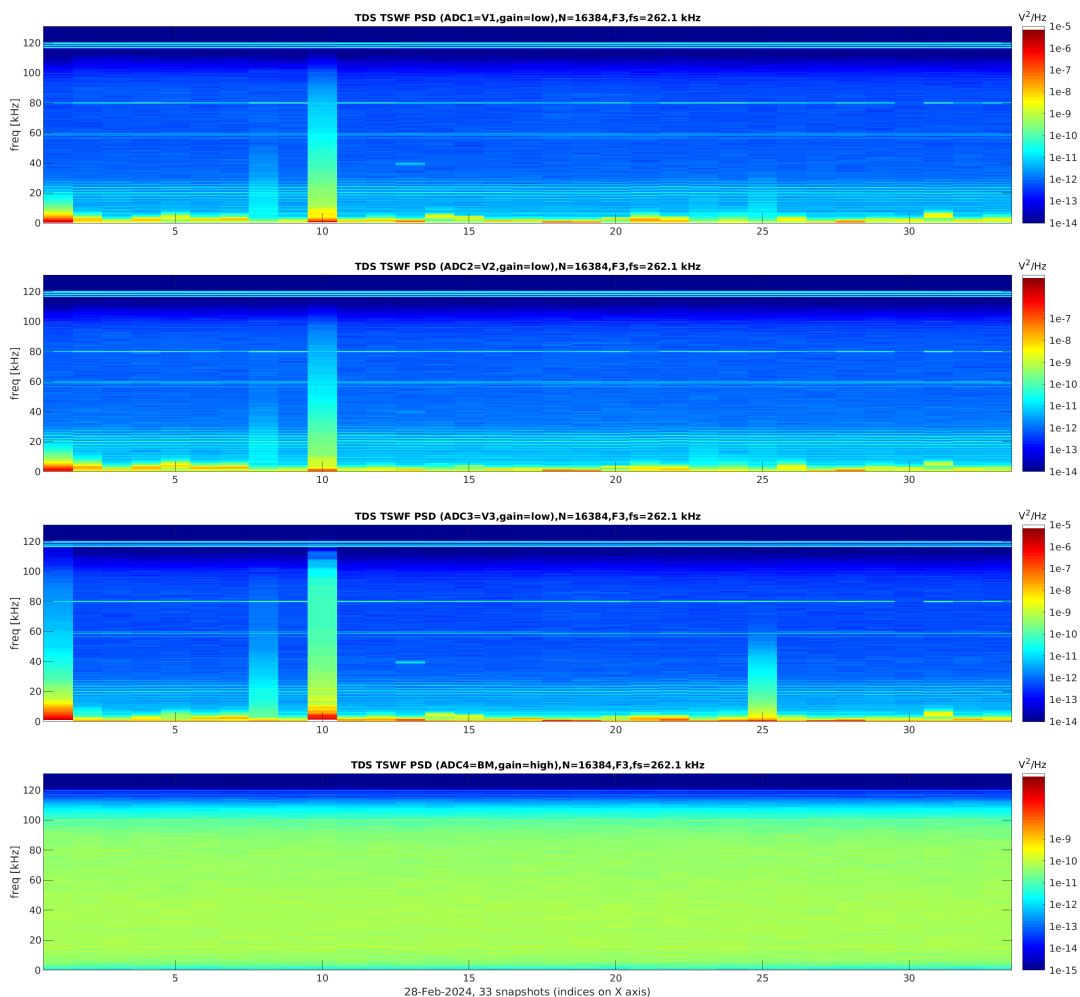
Figure 21. TDS E-field spectrograms from TSWF data acquired on Feb. 28th 2024. V3 channel is the third from the top.

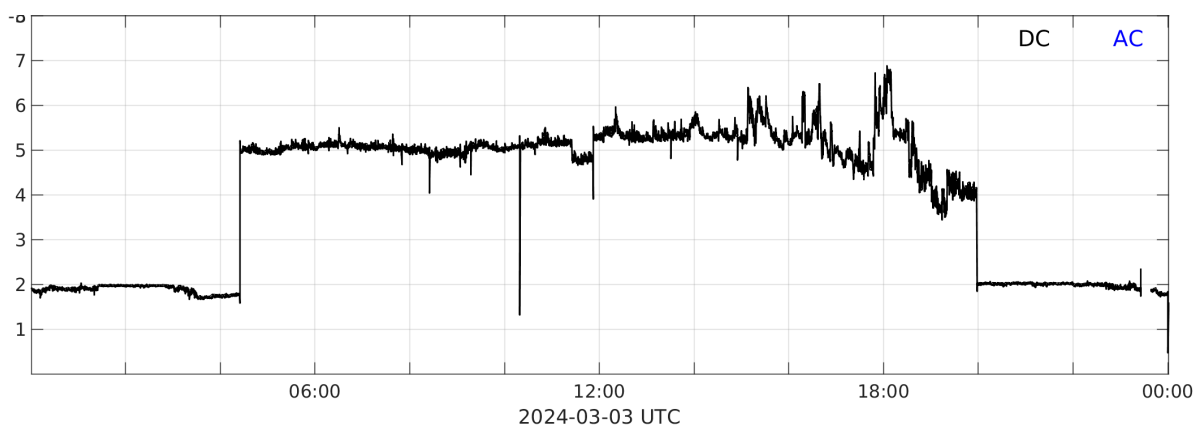
Figure 22. LFR CWF DC field data measured on-board on 2024-03-03.

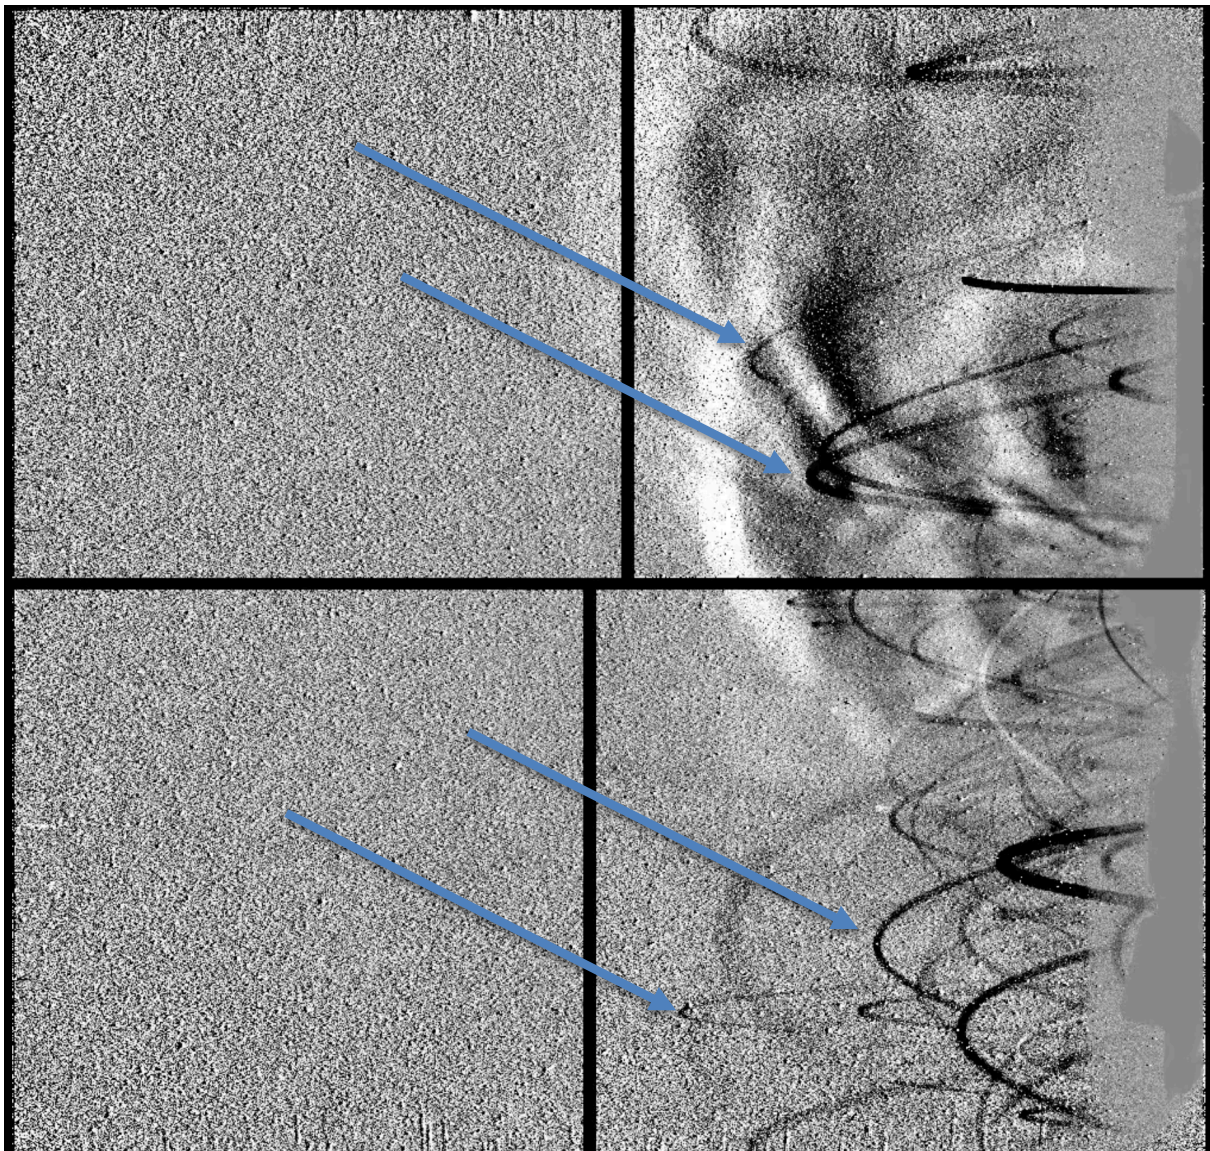
Figure below presents a mosaic image from the SoloHi instrument data on Sept. 2024. Image is extracted from a "ratio" movie where background is removed by dividing two consecutive images. Sun is on the right side of the image, hidden by the S/C heatshield. More or less intense black curved lines can be seen close the heatshield (some are indicated by the blue arrows for illustration). These lines, which are often visible in SoloHi data, could be the trace let by heatshield 'debris' (to be confirmed).

Figure 23. SoloHi mosaic image from Sept. 2023 'ratio' movie
