# PA PHOTOS REPORT

## RPW ANTENNA 3 ANOMALY

ERIC LORFEVRE  
**11/07/24**

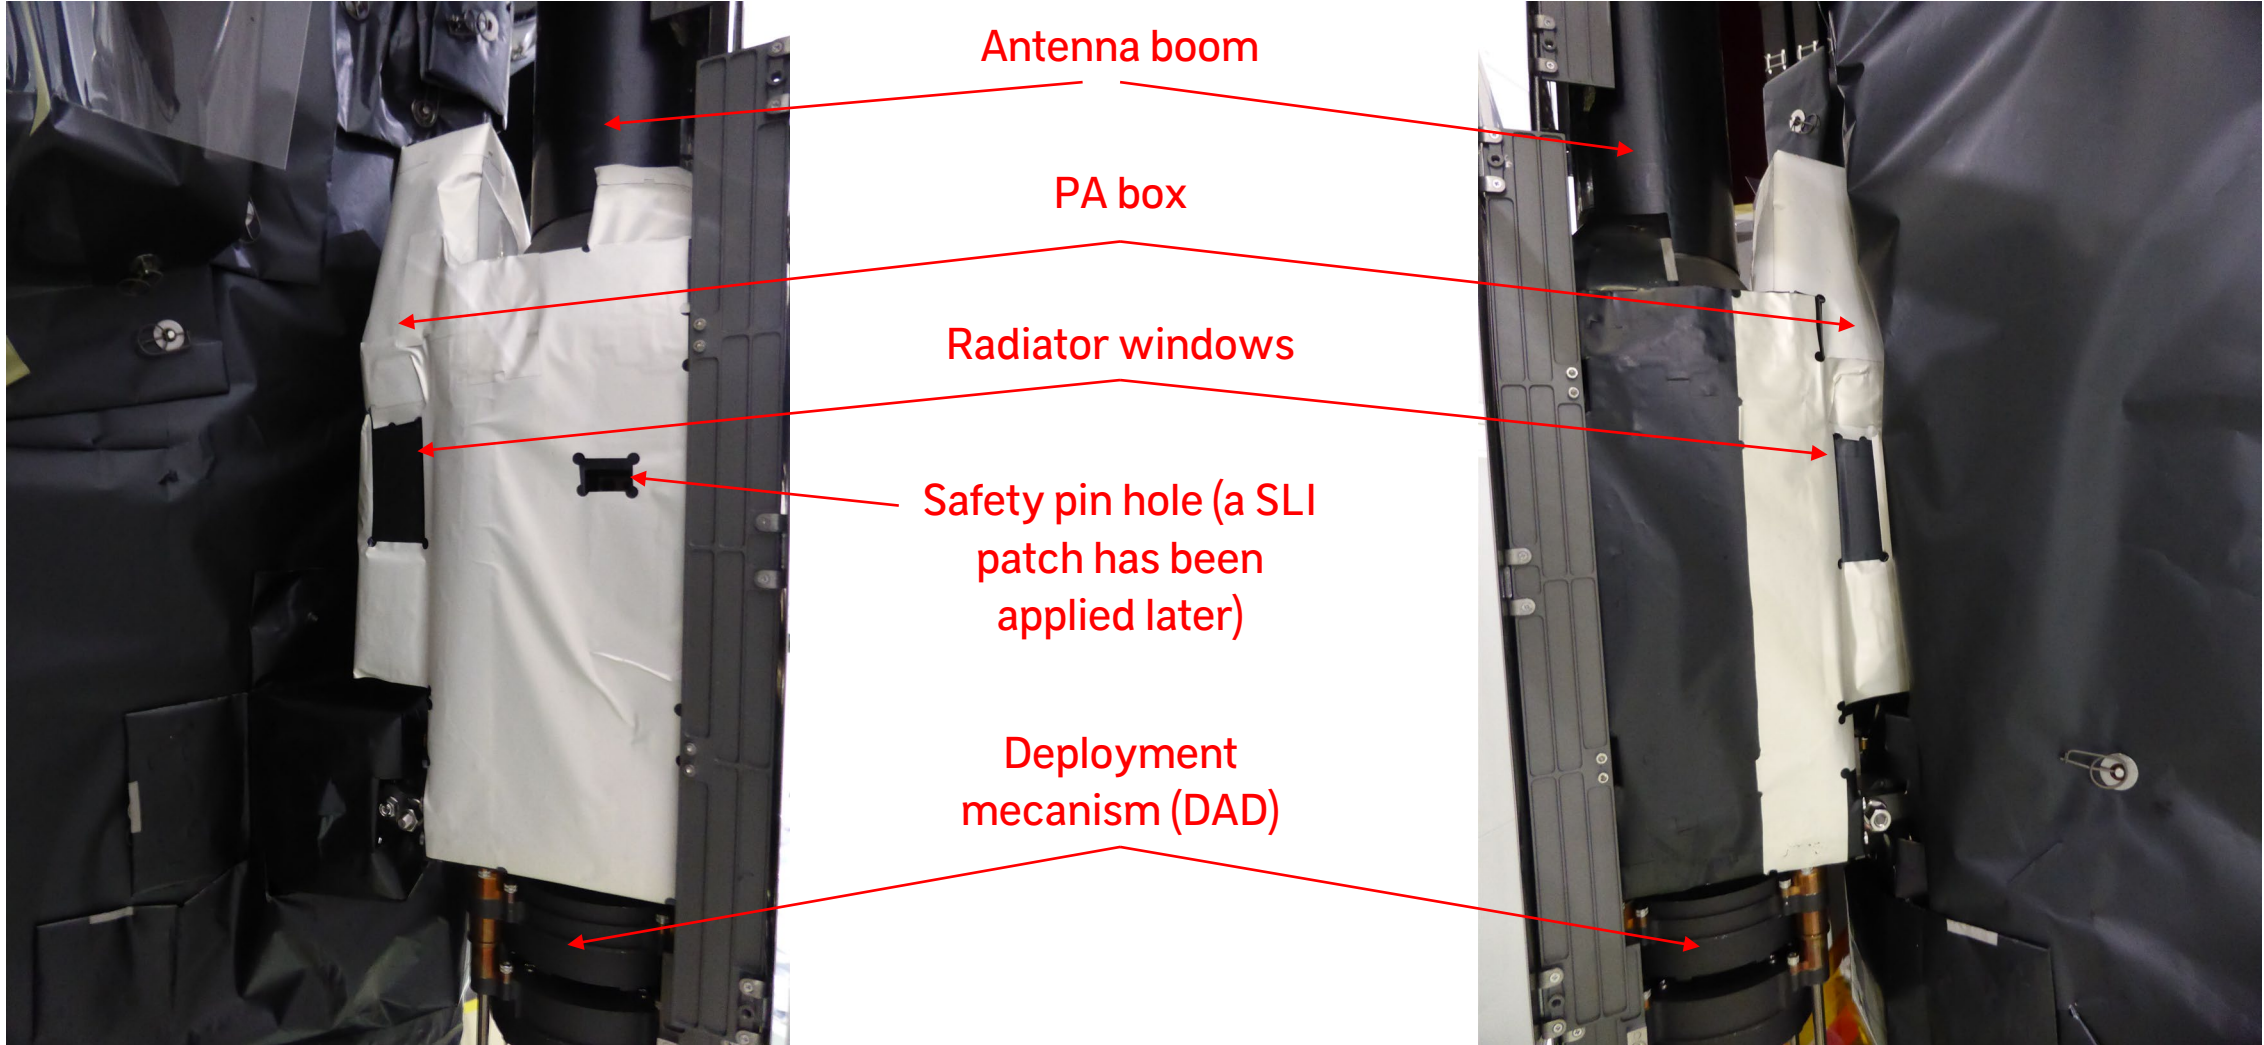
# ANTENNA 3 AFTER SLI INSTALLATION

Face exposed to yoke reflections windows

Opposite face

- ✓ All black kapton MLI surfaces are initially conductive (requirement: to have less than  $3k\Omega$  between two points of any surface. Typical values = some hundred of ohms).
- ✓ Each MLI has a grounding stud to the structure. "bunny ears" have been performed on SLIs to insure electrical continuity with MLI.
- ✓ Folded flaps on SLI allow to fix it also on the internal surface of the MLI

- White SLI peeling off due to yoke reflection and inducing a shortcut
  - ➔ Unlikely. Need large part of "free" SLI to allow a contact with antenna (closer part protected by MLI). A huge thermal effect should be observed.
- Black kapton MLI peeling off inducing a shortcut
  - ➔ Very unlikely. Non expected by thermal predictions especially if SLI is applied. A huge thermal effect should be observed.
- MLI/SLI damaged by external cause inducing a shortcut
  - ➔ Likely/unlikely. Damage on MLI or MLI/SLI without critically damage anything else. Need electrostatic effect or changes of SC attitude to have non permanent anomaly (no correlation observed with attitude changes).  
Limited thermal effect could be observed (depending on the damaged part surface). The shortcut resistance should be around some hundred of ohms or more (if poor contact).
