RPW ANOMALY REVIEW BOARD

April 26, 2024

RPW antenna 3 anomaly (2023-11-13)

Solo RPW Antenna 3 Issue

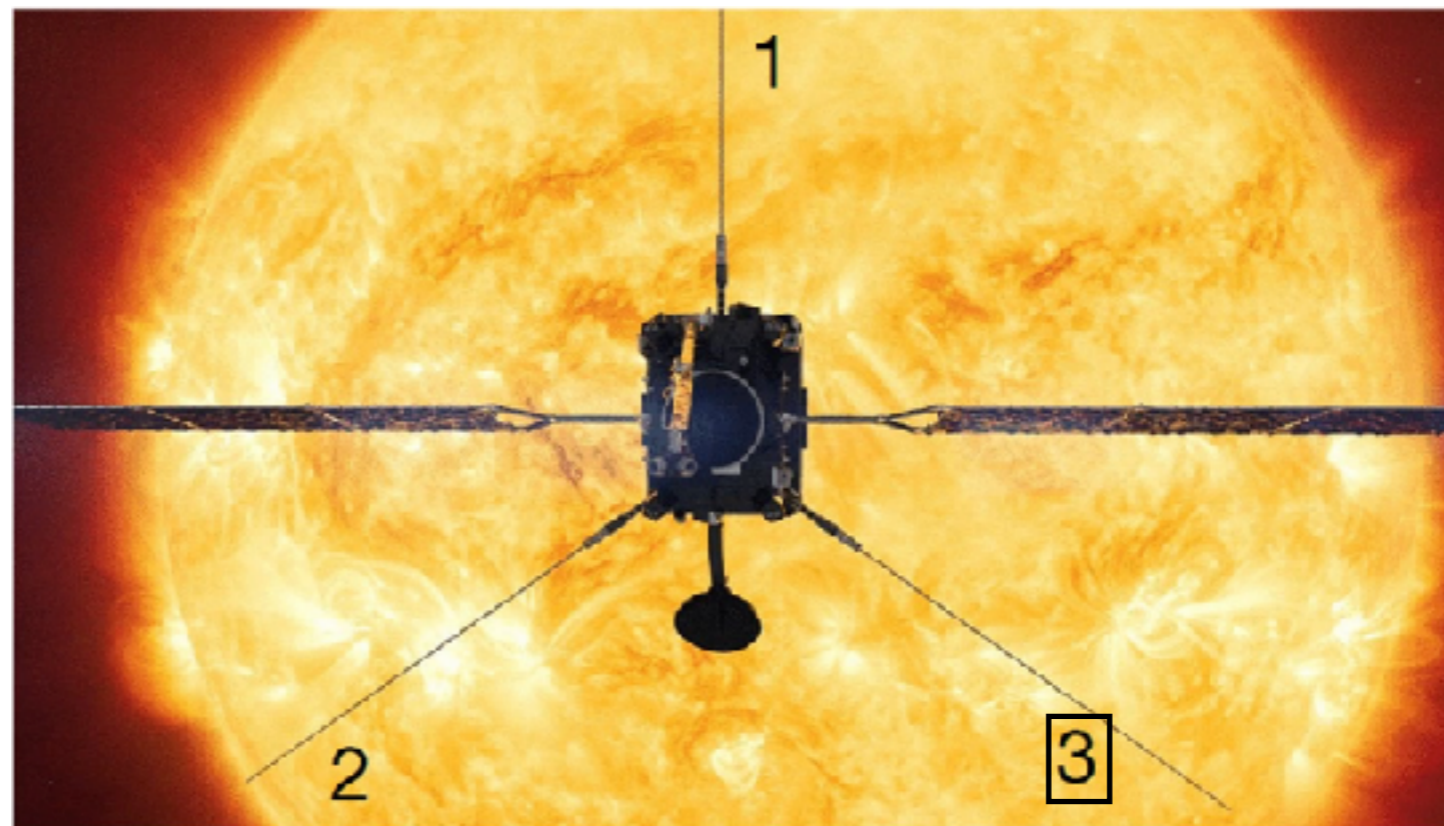
- On Nov. 13, 2023 (STP283) at ~23:36z, RPW electrical antenna 3 [MY] (ANT3) signal was suddenly and unexpectedly changed to constant voltage (~0.7V) during a daily Bias sweep
- No special activity scheduled at this time for RPW or payload in general
- Occurred during a S/C attitude disturbance ("SLEW")

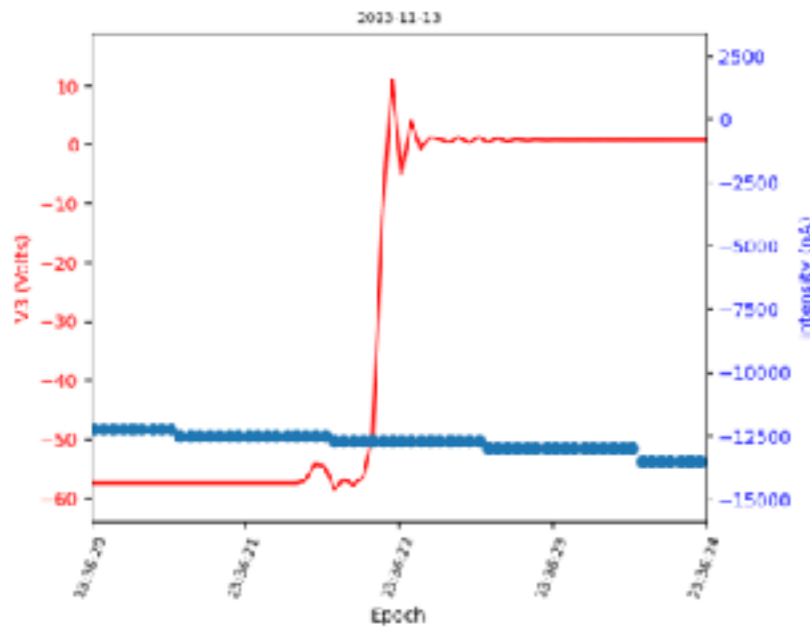
LFR CWF data on Nov. 13 around 23:36z

- RPW Low Frequency (LF) measurements around anomaly time

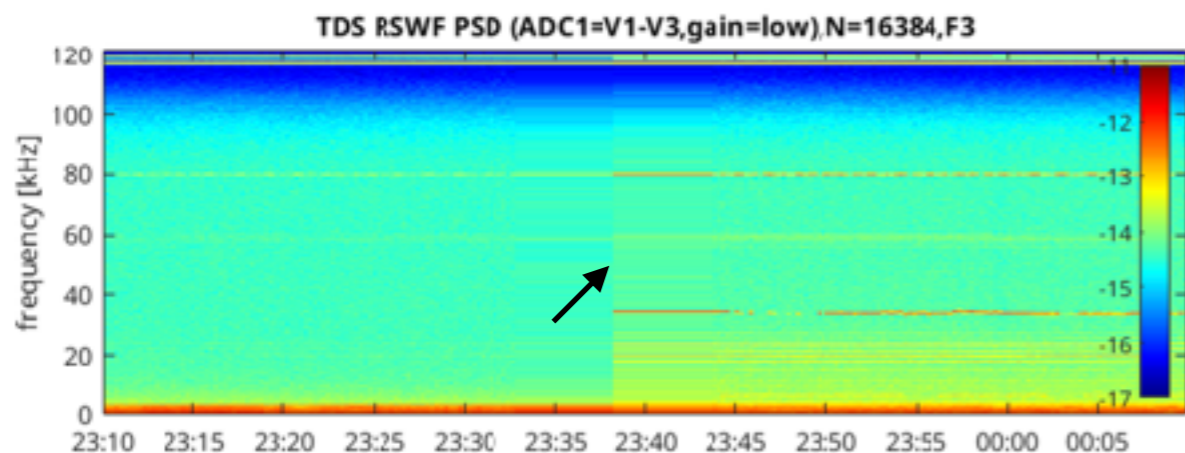
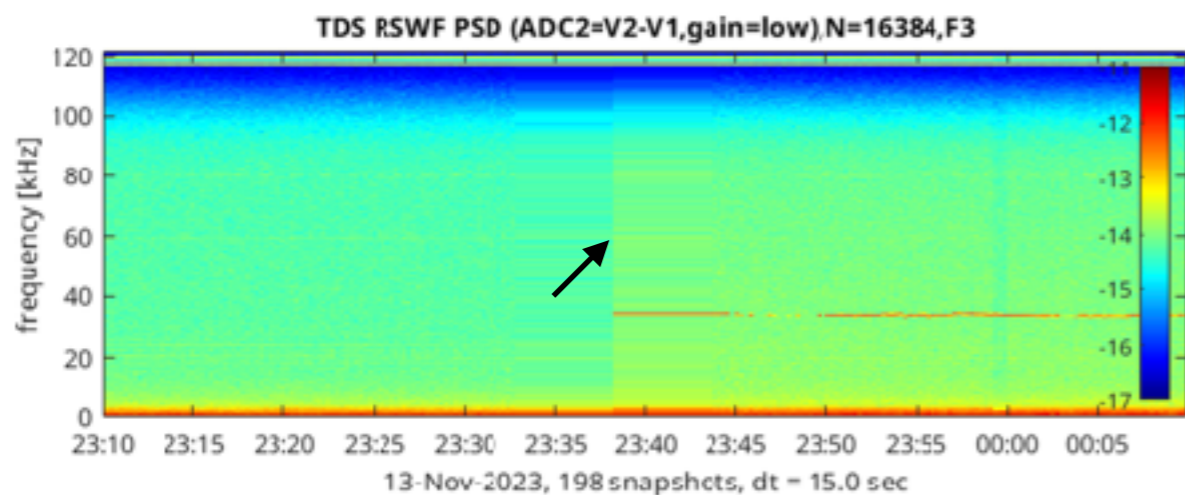
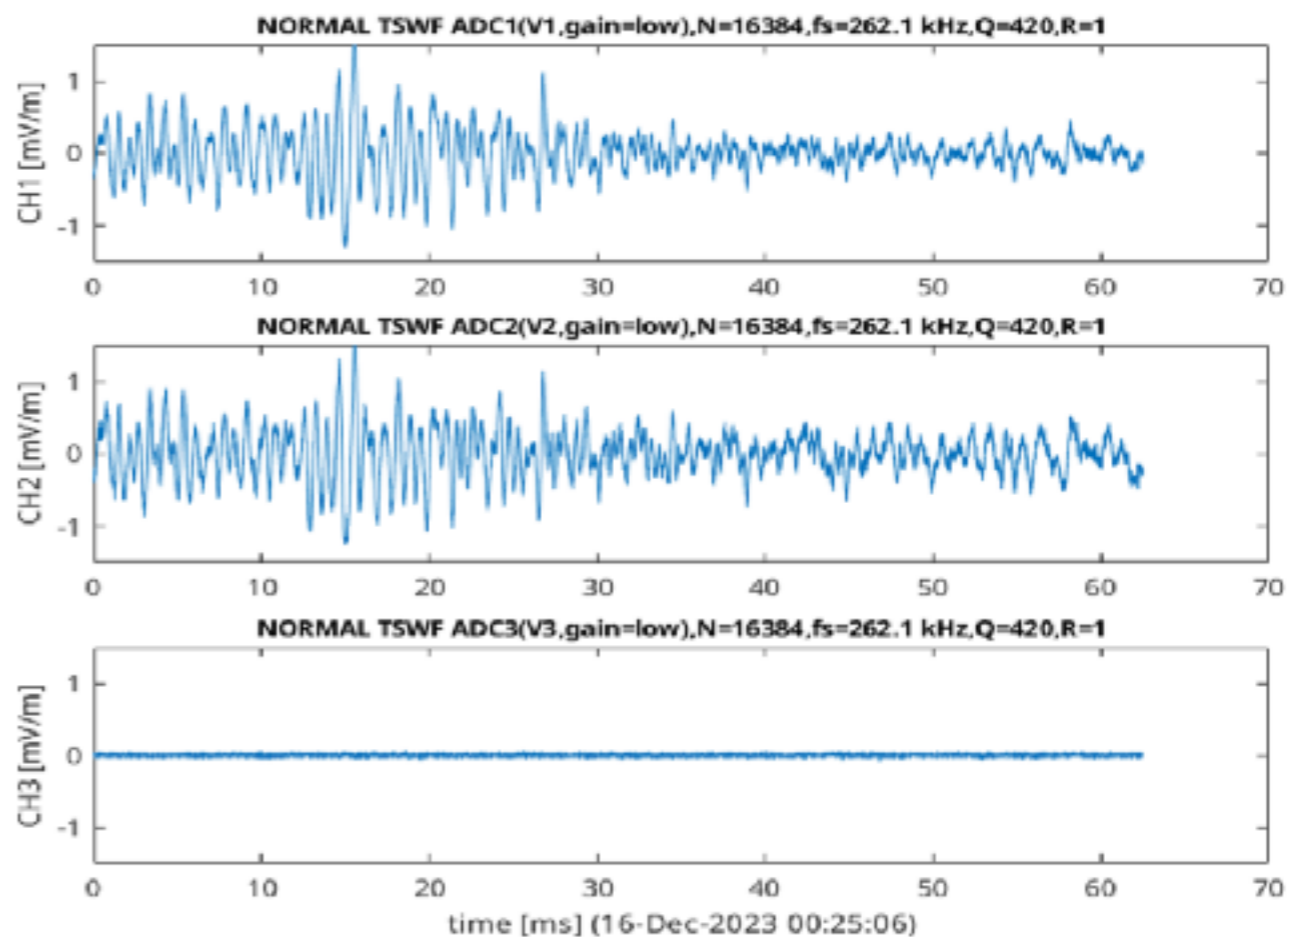
- Also observed in High Frequency (HF) measurement (here on TDS data)...

TDS Triggered Snapshot Waveforms (TSWF) acquired during TDS diagnostic test on Dec. 16, 2023

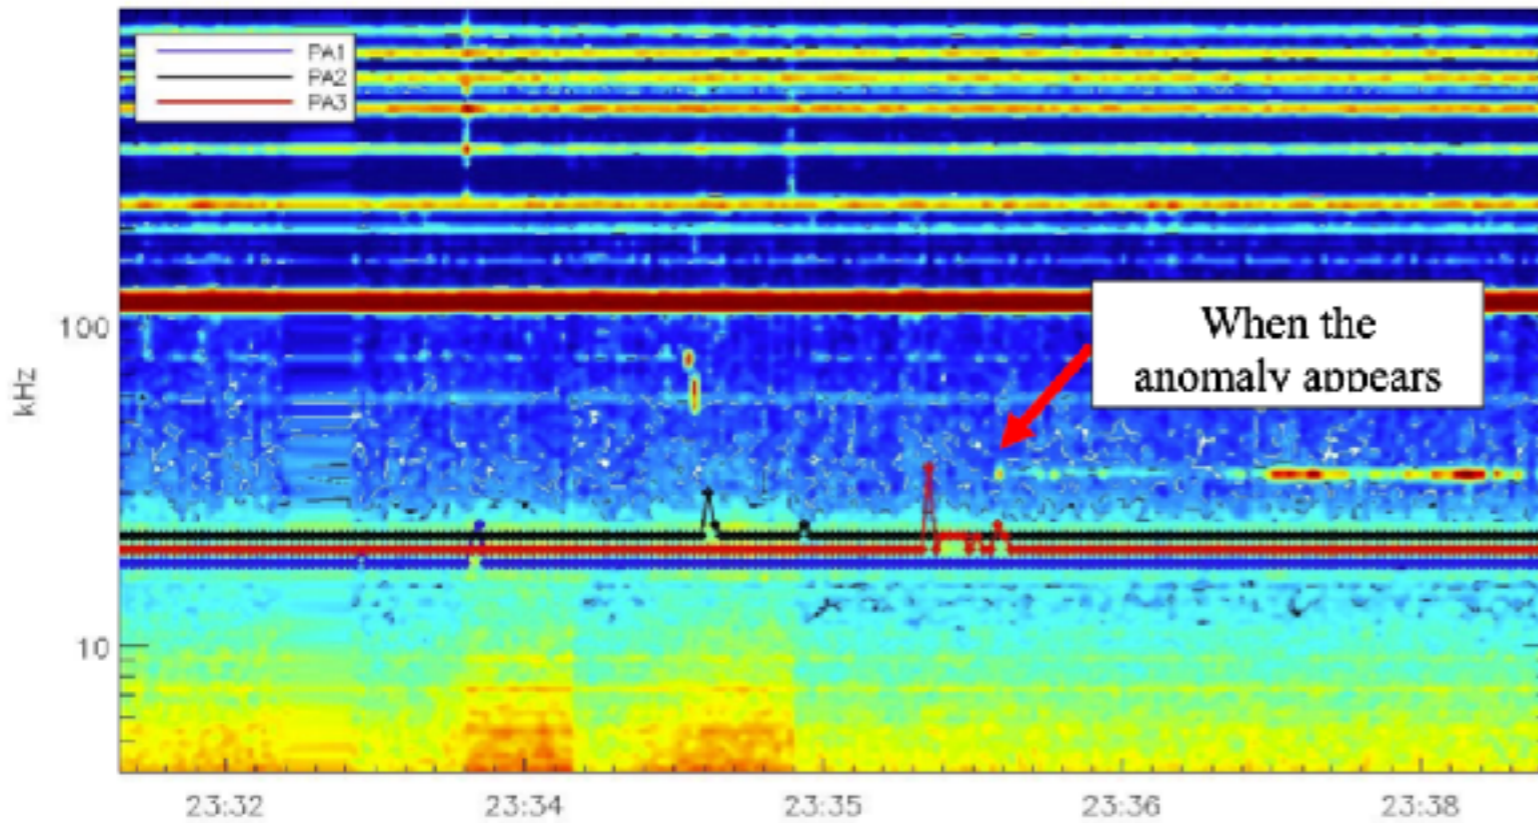
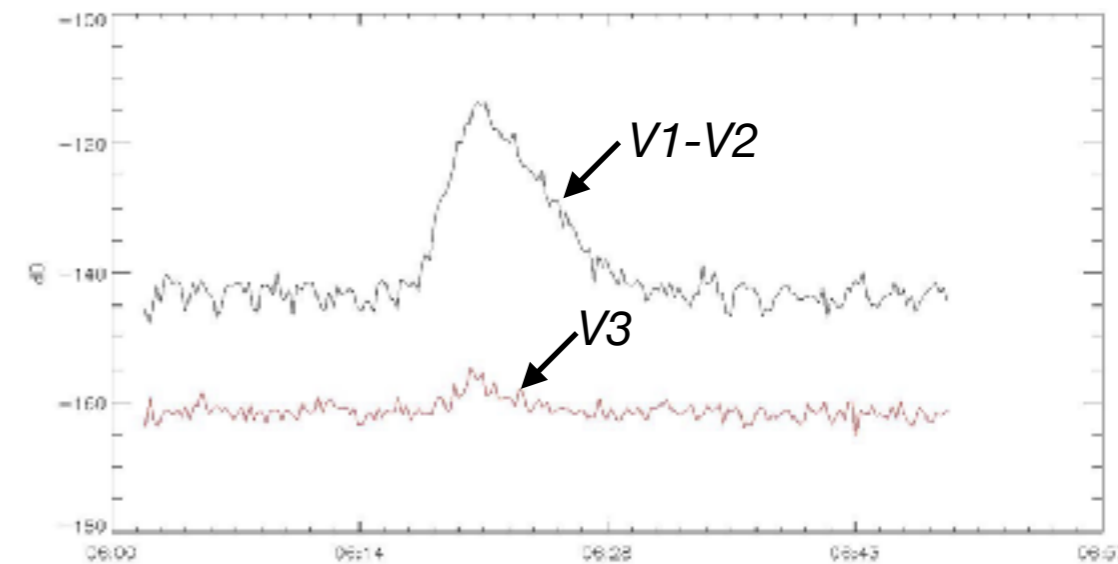
Type III burst seen on Jan 22, 2024 by TNR at ~634 kHz

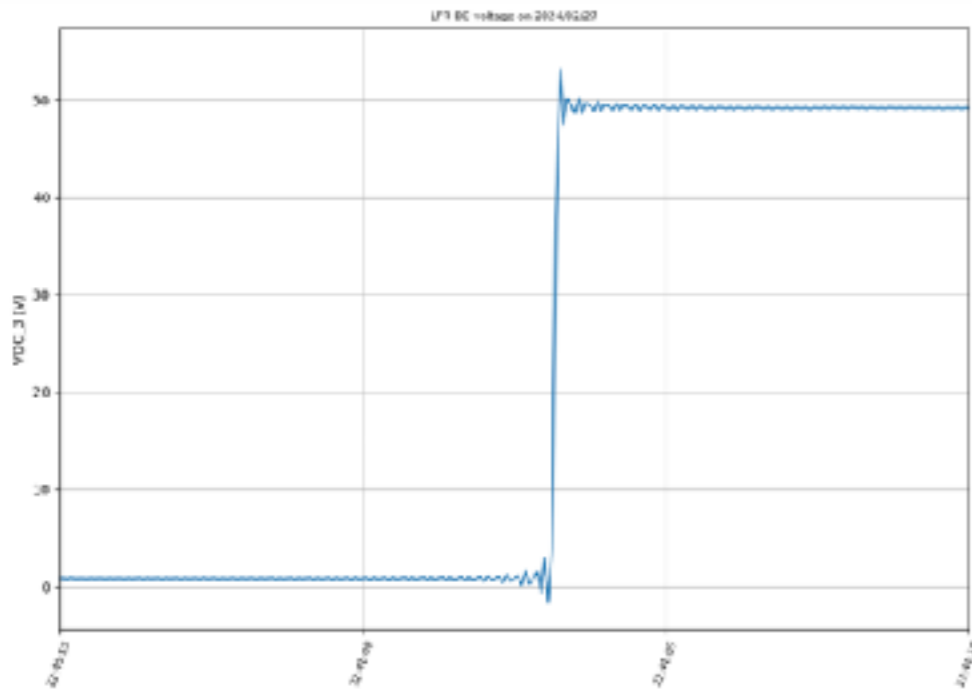
- ANT3 signal went back on Feb. 27, 2024 at ~22:40z,
 - Recovery was confirmed by all RPW subsystem teams
 - No special activity scheduled by RPW or in "E-FECS" at that time
 - ANT3 was lost again several times after Feb. 27, 2024 (see table below)

V3 DC voltage measured by LFR (CWF) suddenly changed from 0.7V to 49V on Feb. 27, 2024 around 22:40z

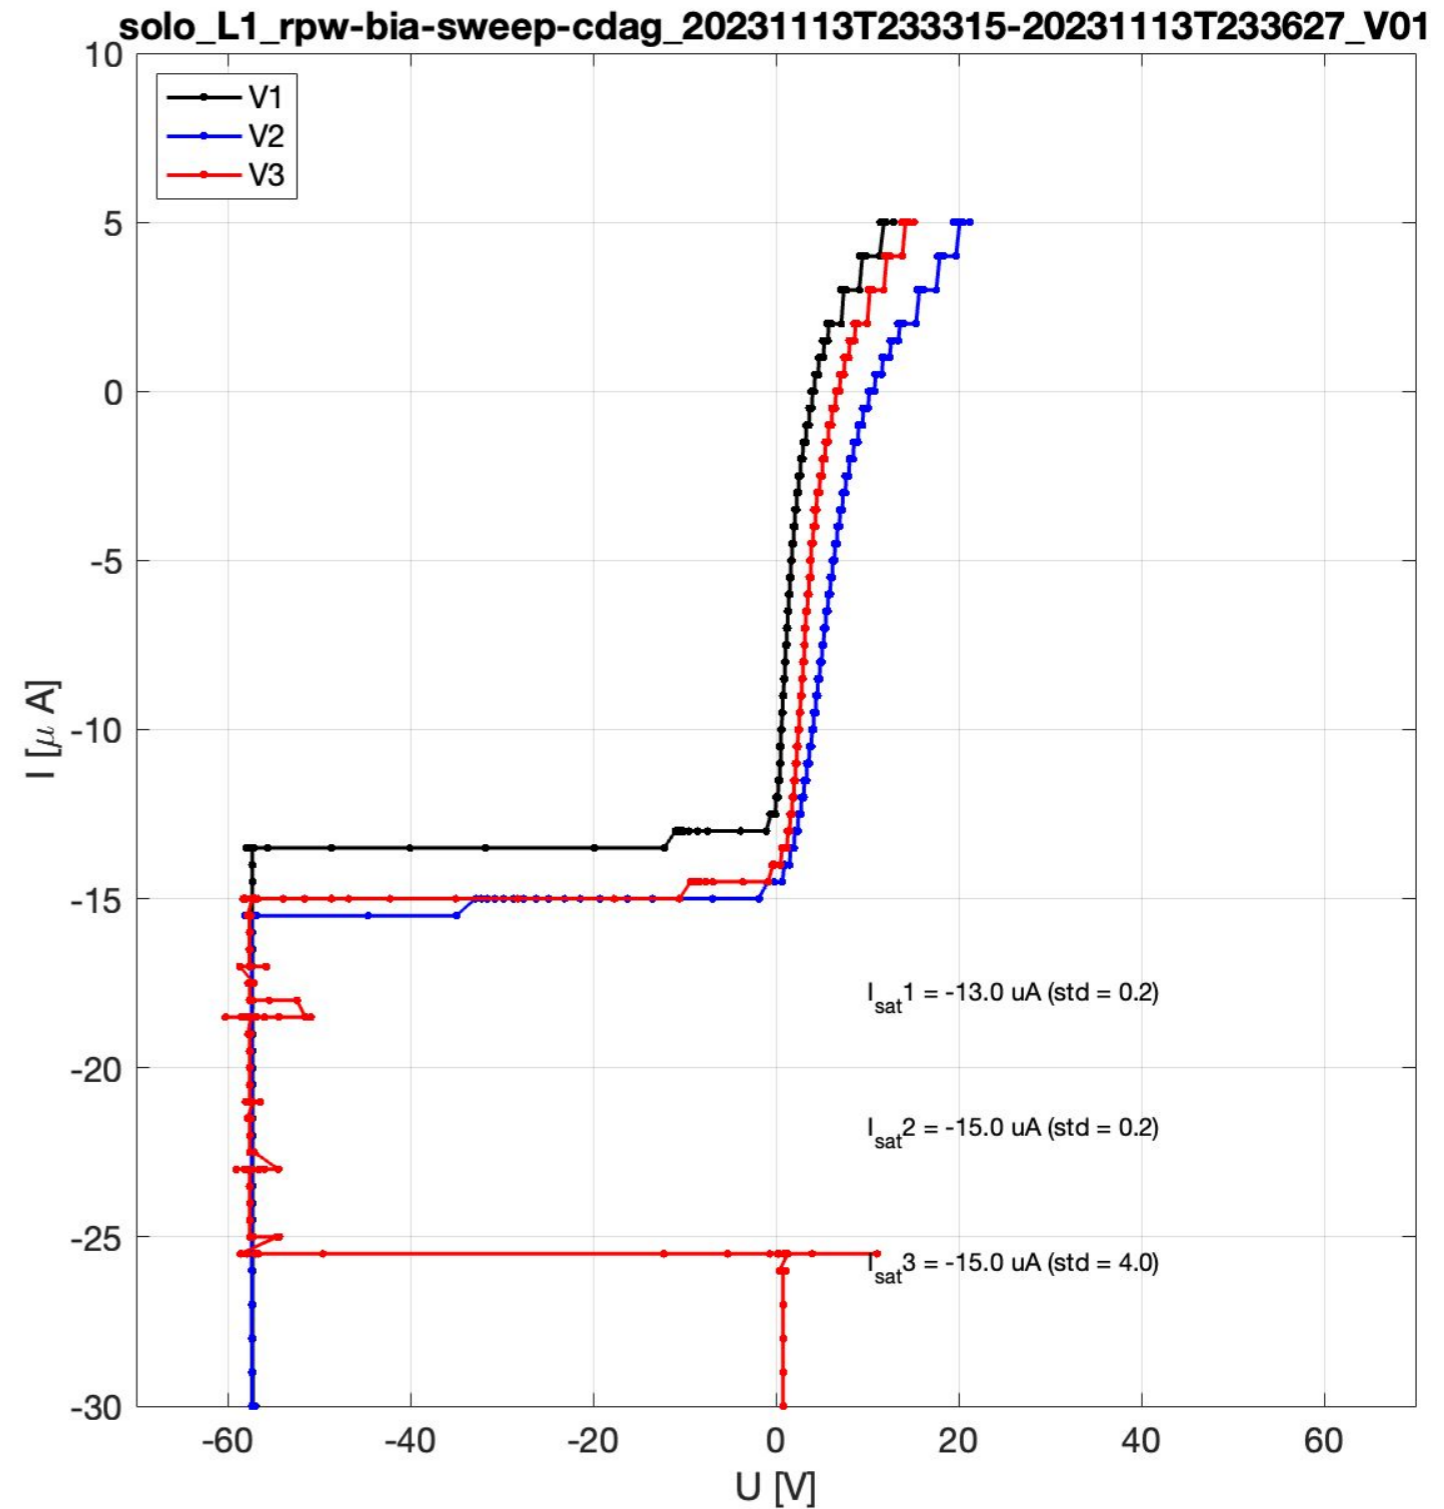
First identified appearance

Found by Niklas when evaluating photosaturation current.

First suspicion was some electronics problem so initial efforts concentrated on finding where.

Calibration sweeps (later slides) showed the issue is a short outside the BIAS preamp.

A short due to conductive debris settling might be intermittent and partial at first, as observed.

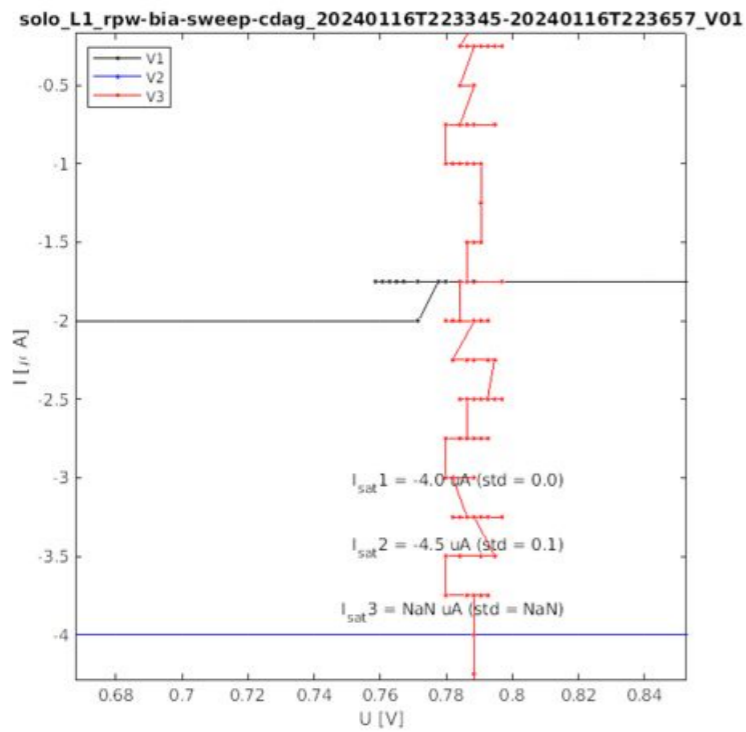
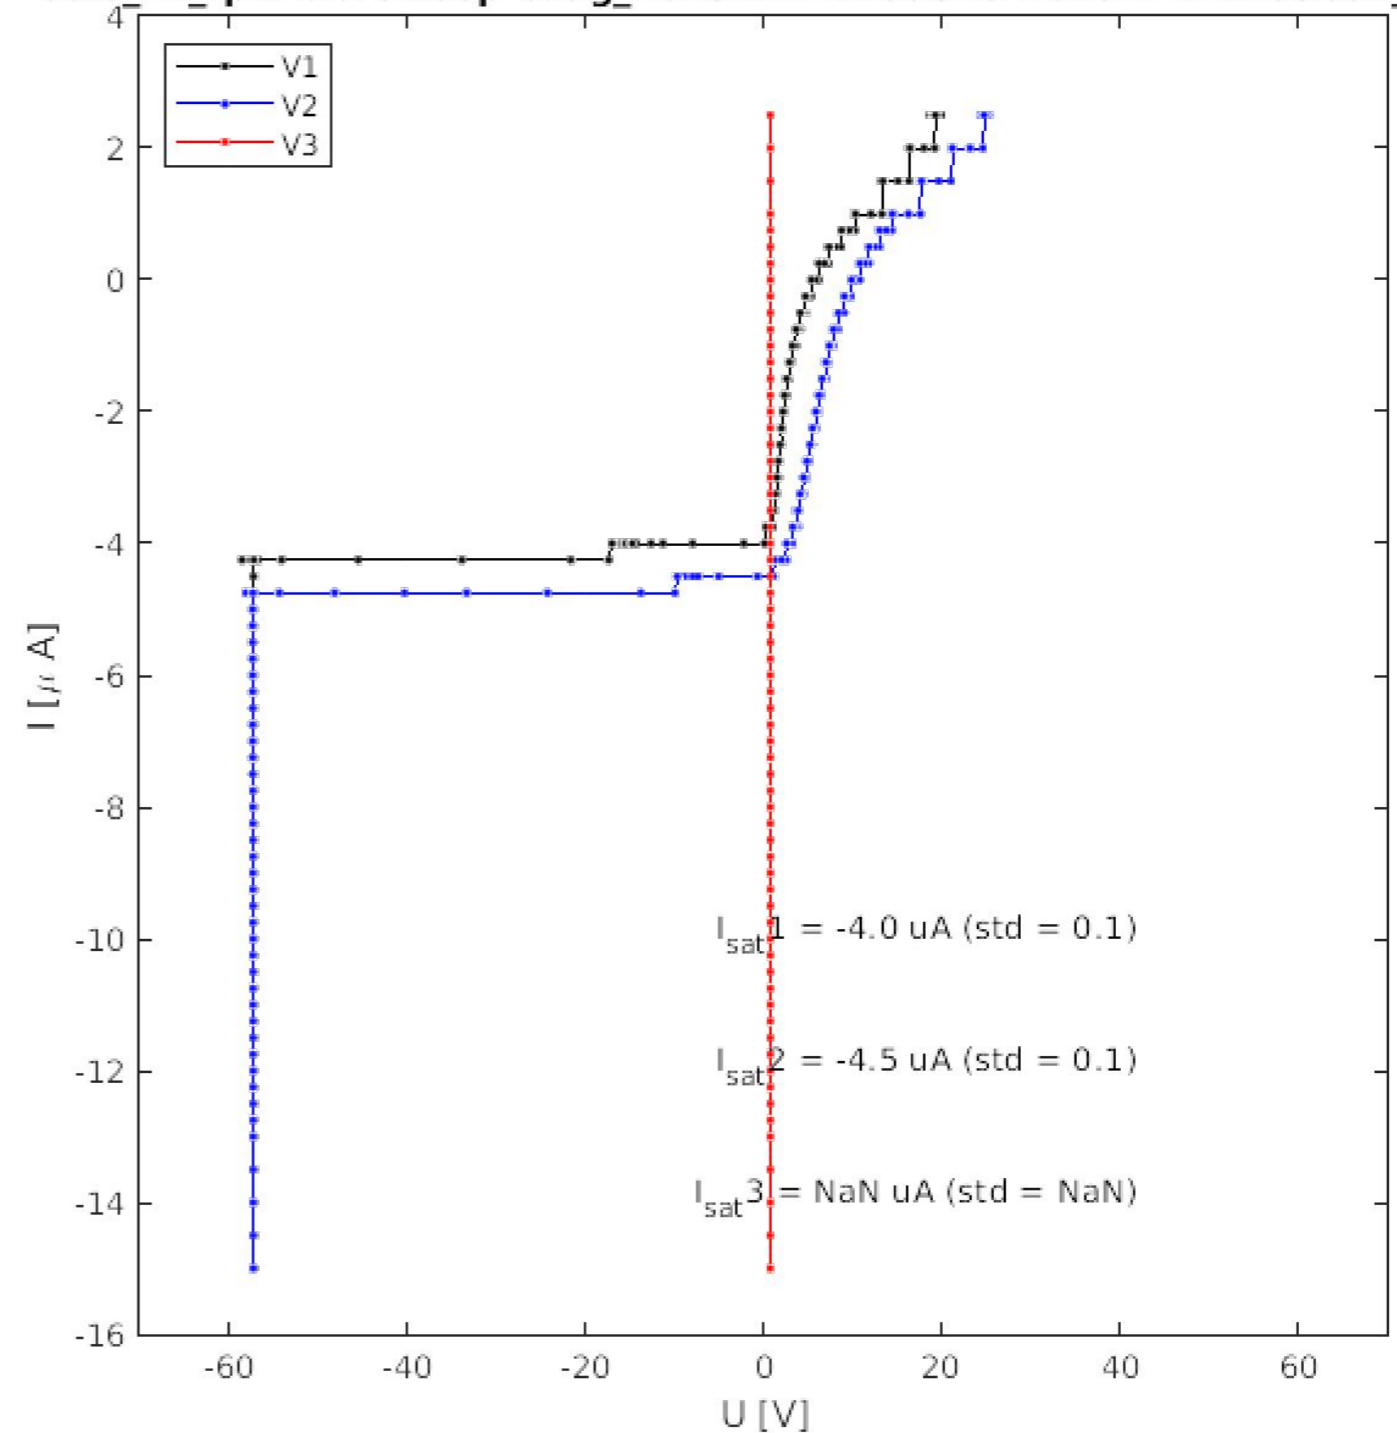
Subsequent sweeps

Stable ($\pm 10\text{mV}$) and slightly positive ($\sim 0.8\text{V}$) output voltage on antenna 3 for all input bias currents

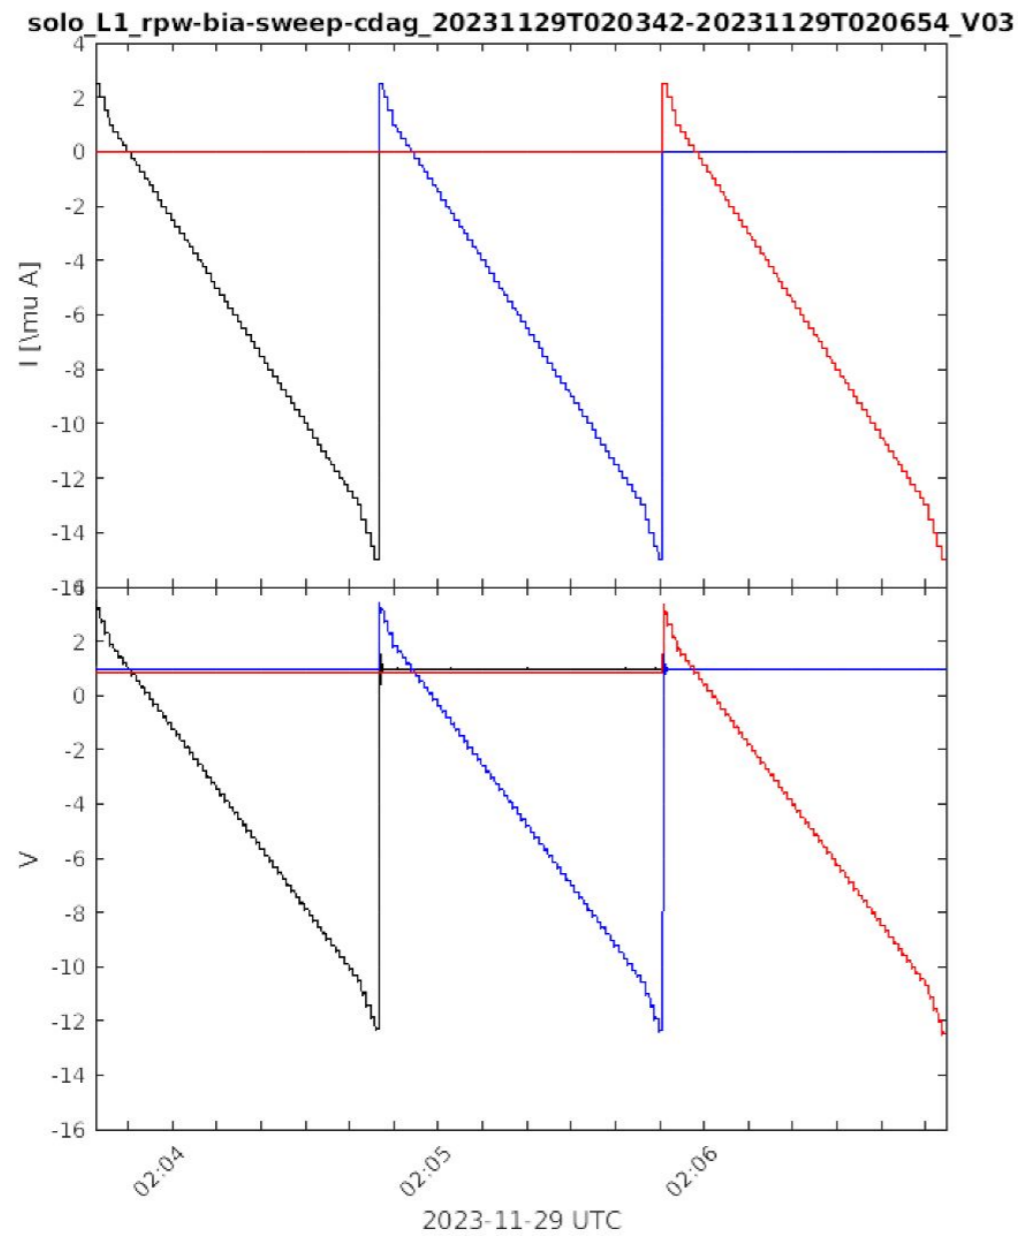
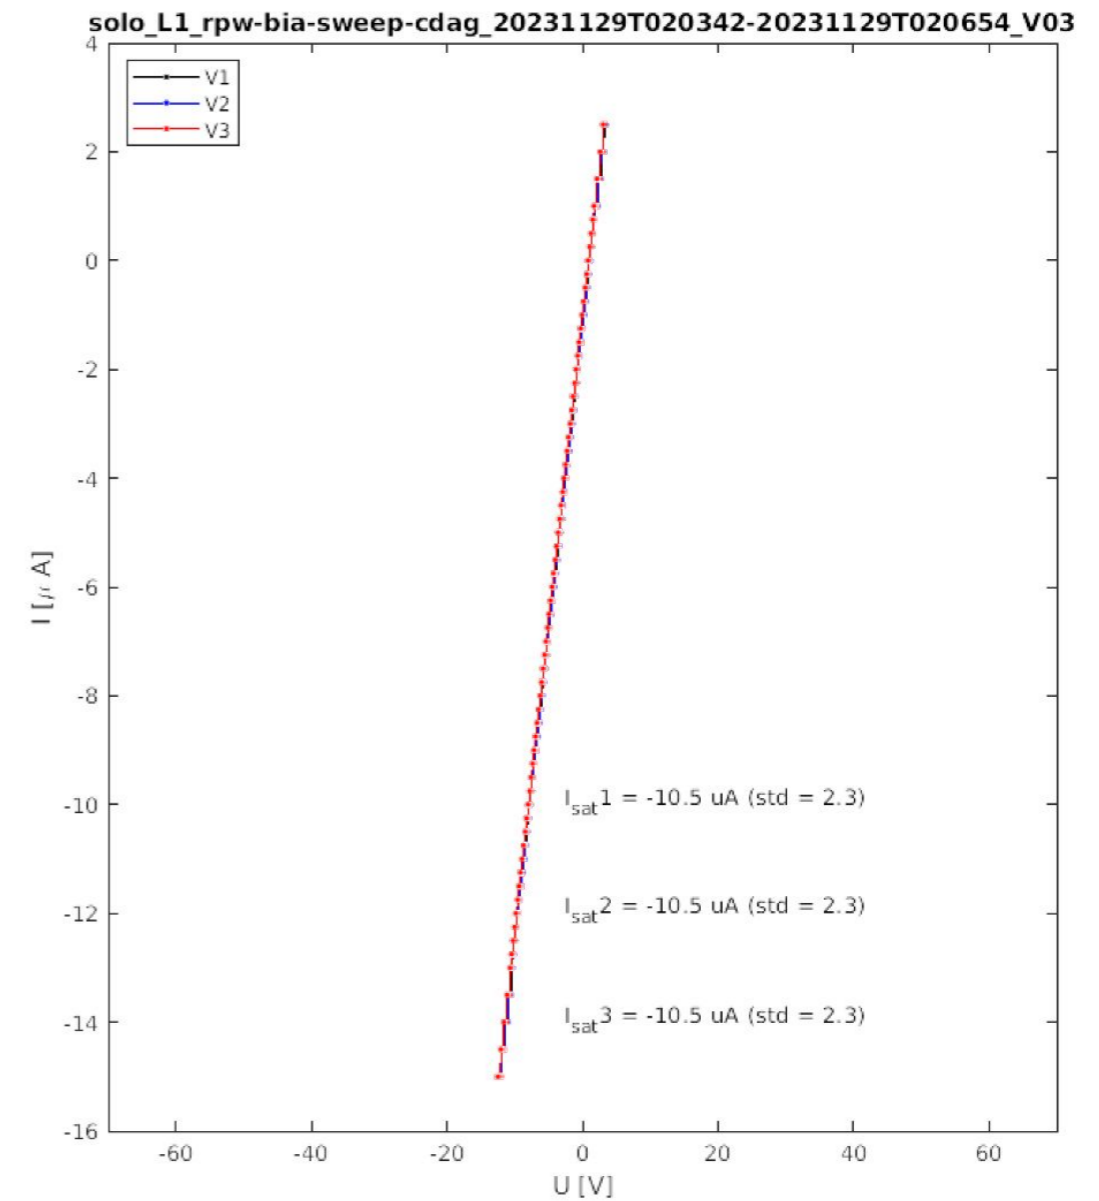
Sweeps over cal resistor

Perfectly nominal on all antennas

=> BIAS electronics nominal

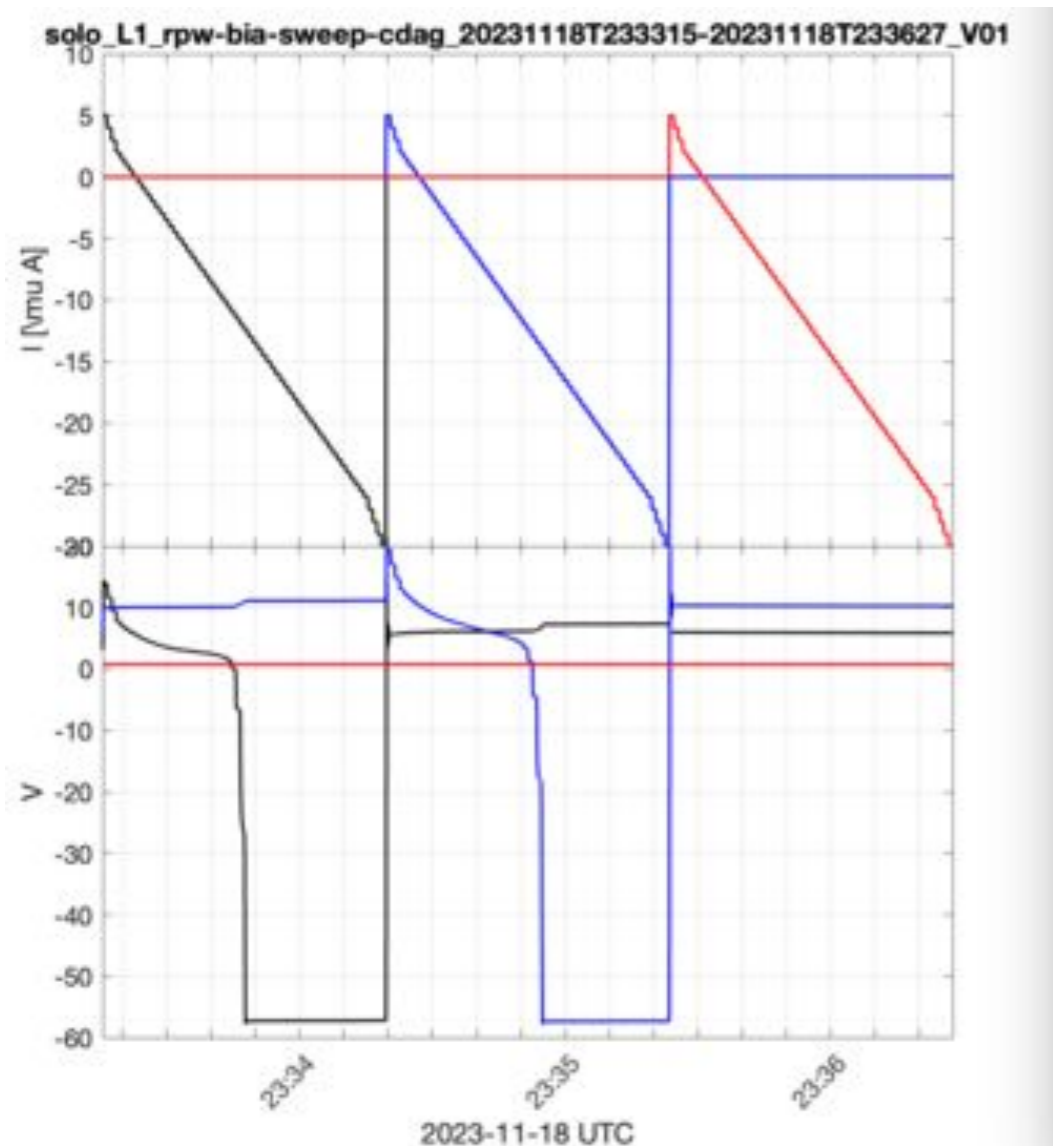
Sweep impact on Vsc

Until the anomaly, the voltage on two antennas could be seen to vary when the third is swept. This is expected as the s/c potential adjusts to the varying current.

Since the anomaly, antennas 1 and 2 still show this effect when the other is sweeping, but nothing is seen when we sweep on 3.

This is consistent with antenna 3 being shorted to ground.

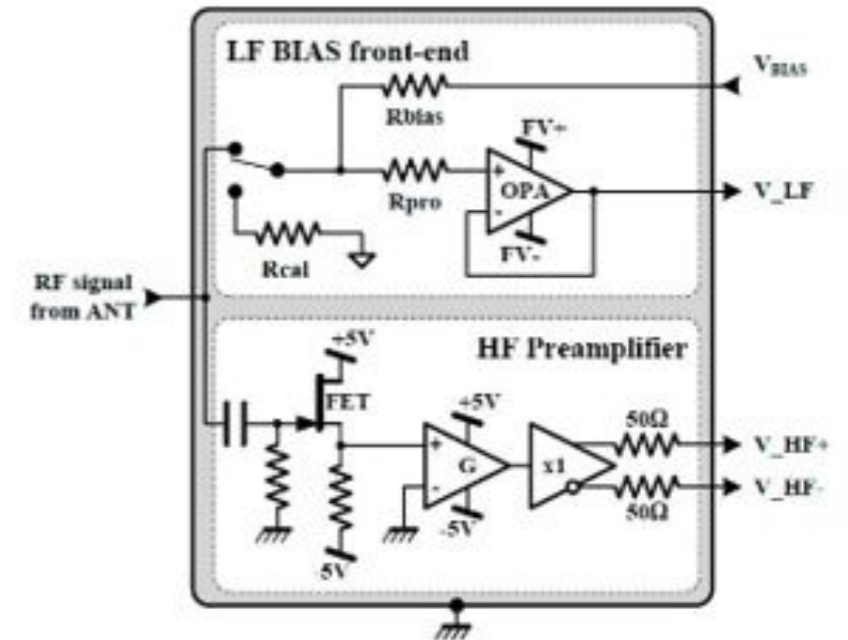
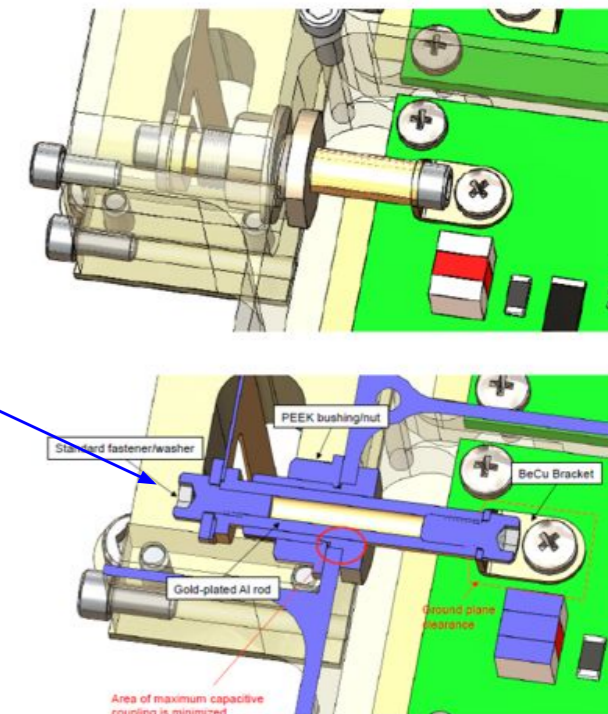
Failure modes

The short must be outside of the bias cal relay.

The route between preamps and antenna appears to include exposed conductors possibly in the vicinity of MLI, therefore possibly prone to fringes of (the upper layer of) MLI torn by a micrometeoroid impact. Small MLI fringes likely have lower mechanical resistance to bending and would be more easily attracted by weak electrostatic forces than intact MLI sheets loosened by e.g. a glue failure.

Fig. 8. Antenna preamplifiers electrical design. See text for more details.

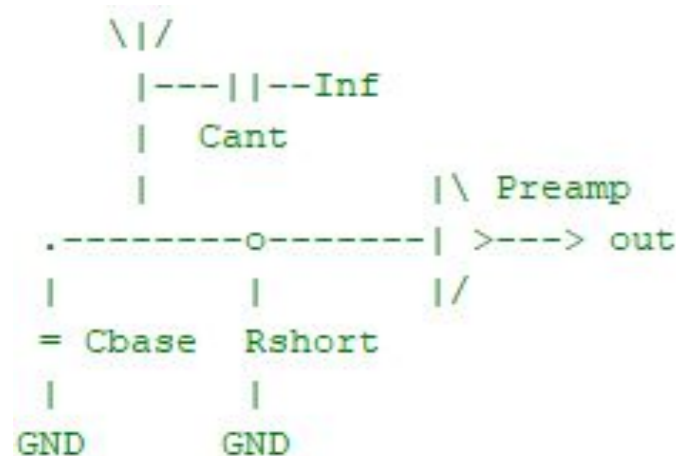
Equivalent short resistance

Based on Antonios plot on the solar burst signal difference between V3 vs V1-V2 (~45dB @ 634kHz) the equivalent ohmic resistance can be calculated.

Given is that the antenna capacitance to infinity is ~63pF and the antenna base capacitance is ~77pF and the JFET preamps adds another ~33pF (The Solar Orbiter Radio and Plasma Waves (RPW) instrument) the damping of the signal would be a similar result as if there was a shot to S/C GND from the antenna element of about 61 ohms.

It should be noted that this short is intermittent and has also in some occasions shown much higher resistance (hundreds of mega ohms)

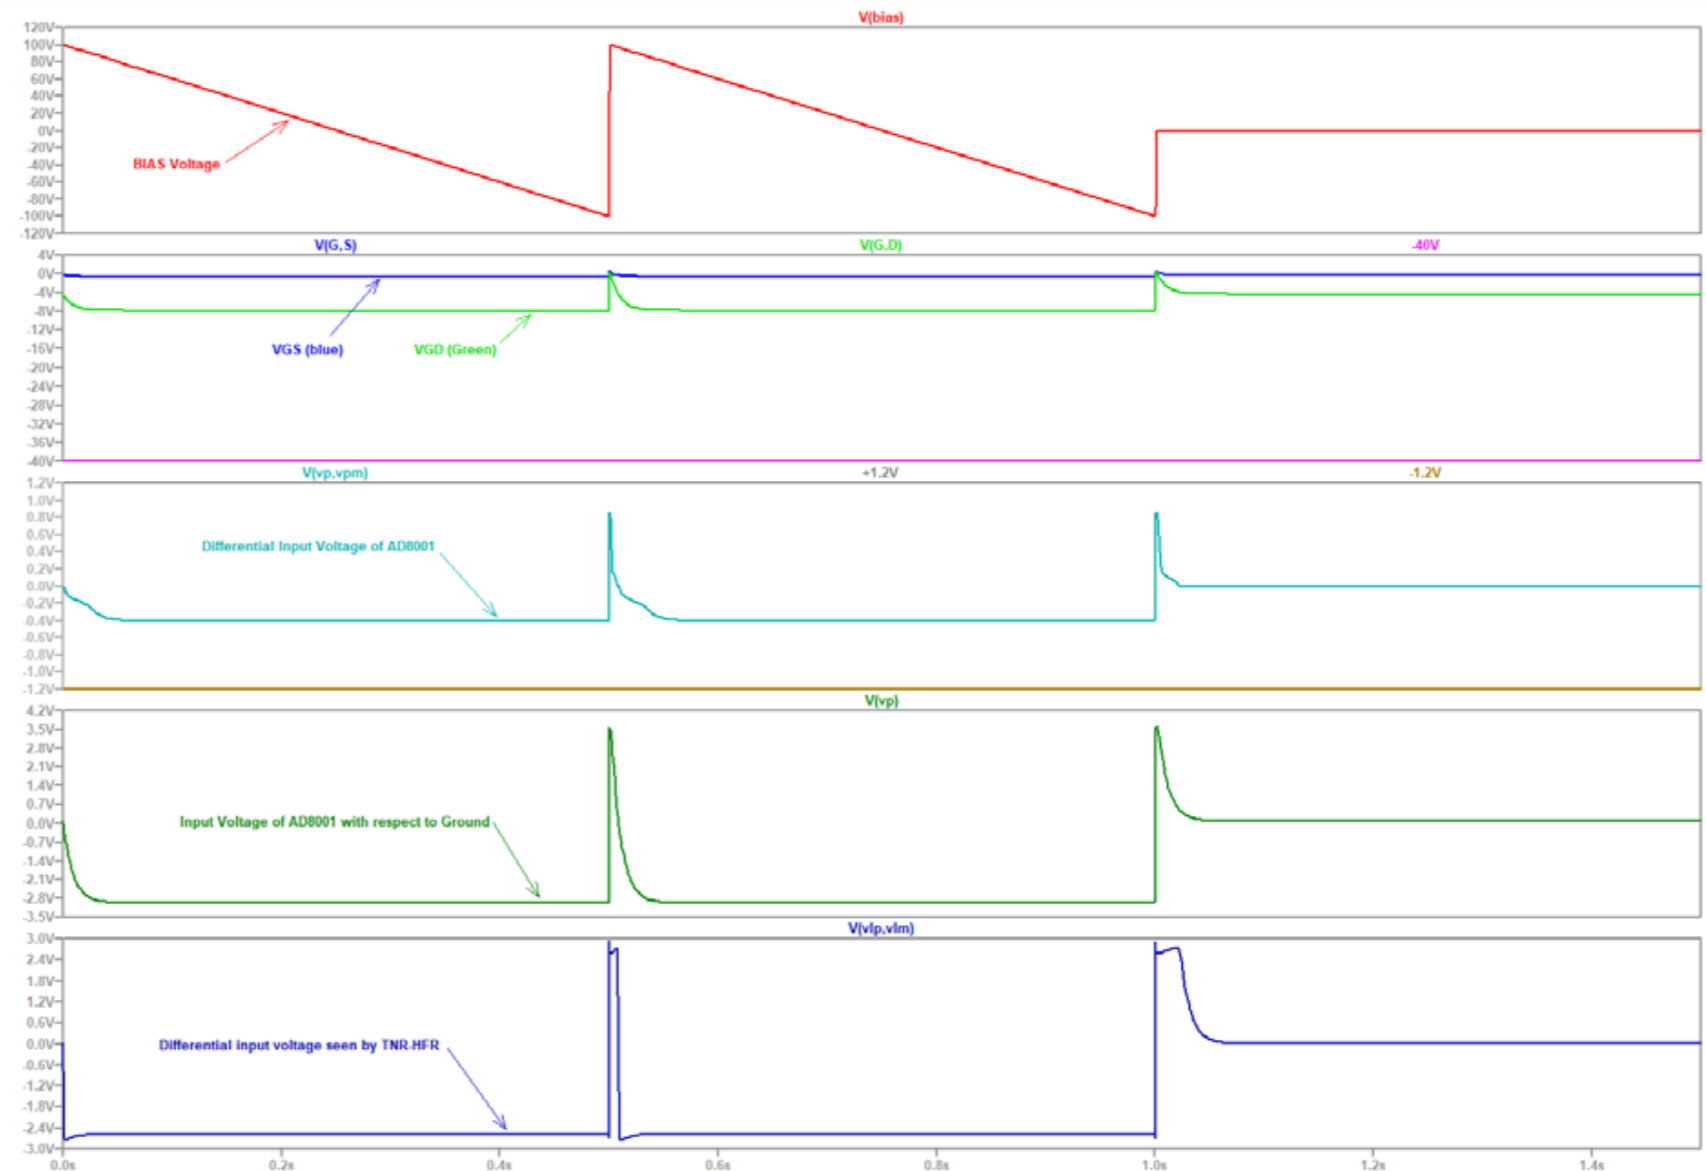
Derating satisfied with comfortable margins despite the large ramp → **no stress**

Output voltage pulses occur on the rising edge of the BIAS sweeps → this explains the consumption peaks due to the 110 ohm load

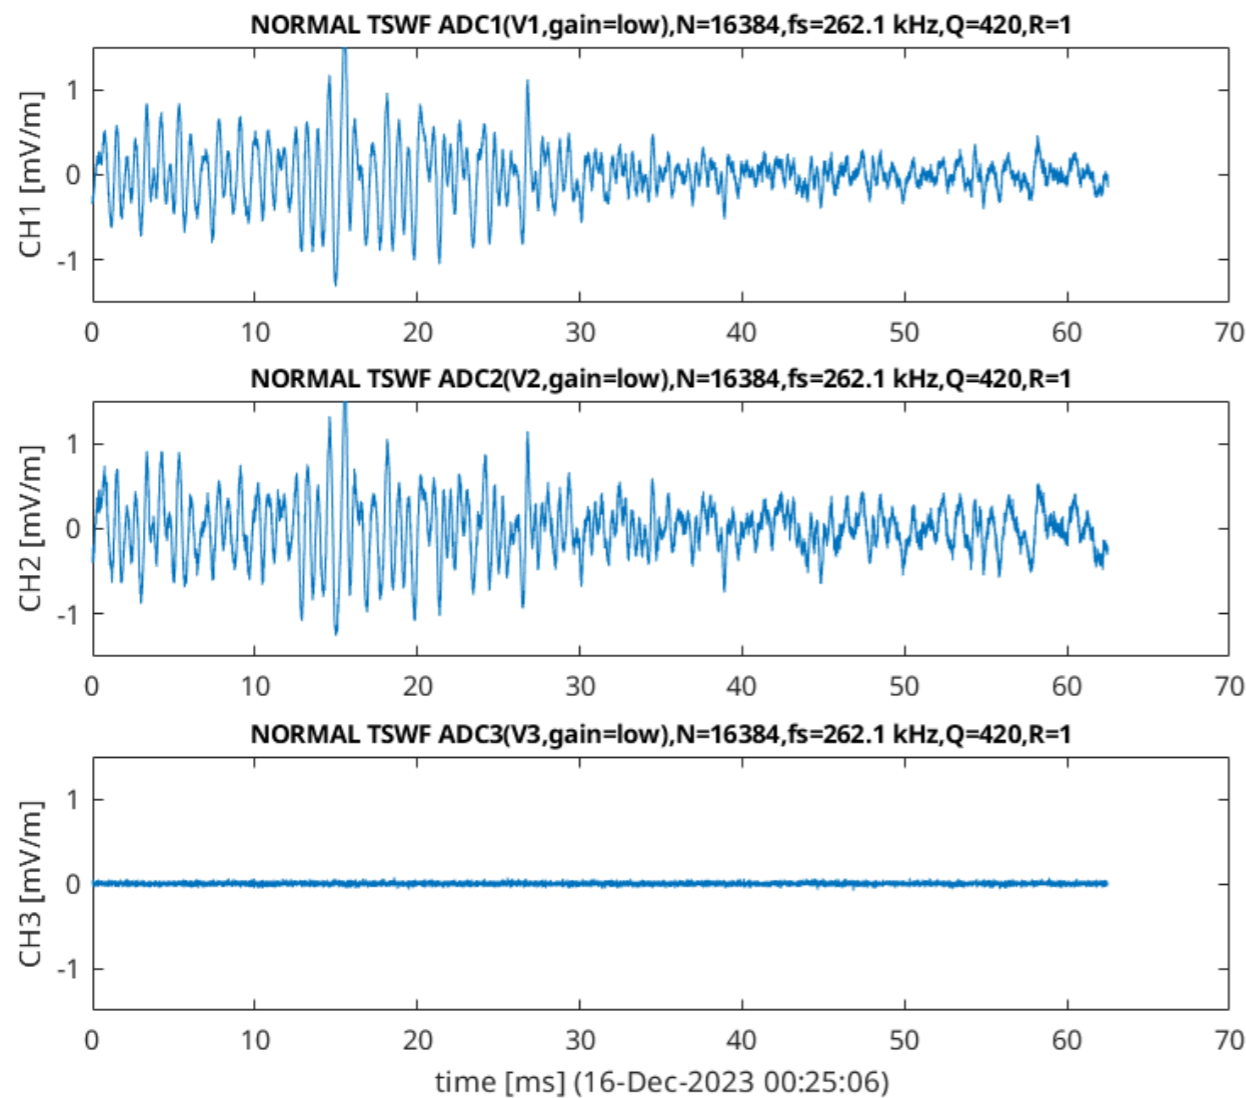
TDS data after the anomaly

- ❑ On December 16, TDS was configured to a monopole mode, where each channel samples a single antenna.
- ❑ Clearly, Antenna 3 sees no signal at all
- ❑ TDS uses a high frequency preamplifier (different from the one used by the RPW bias), but sharing the same antenna connection “pigtail”

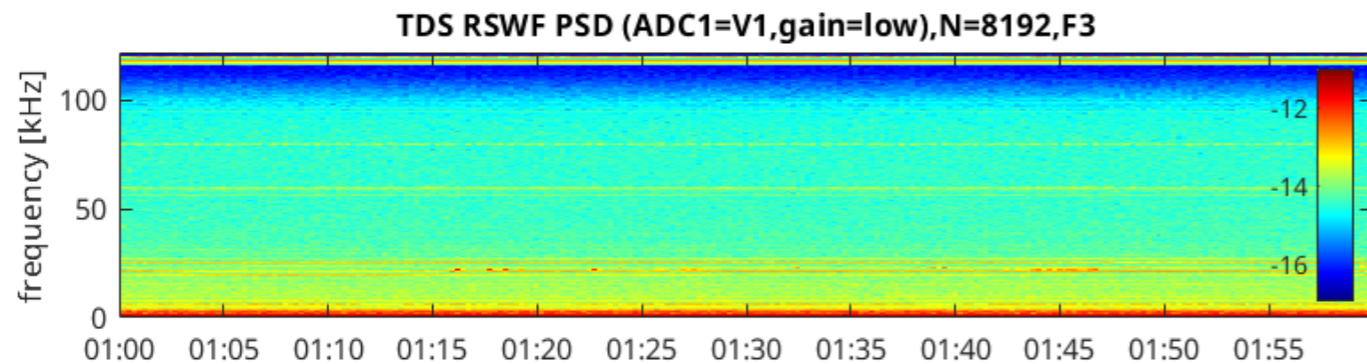
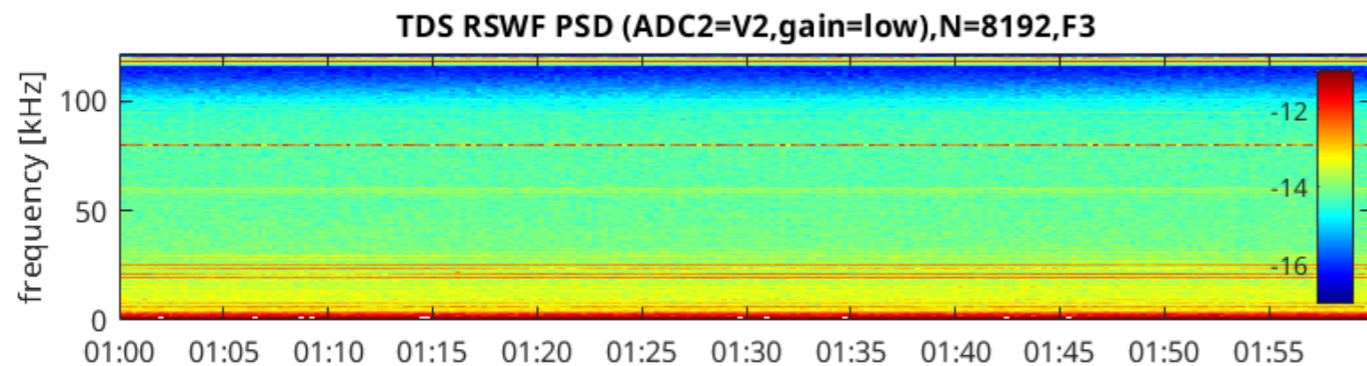
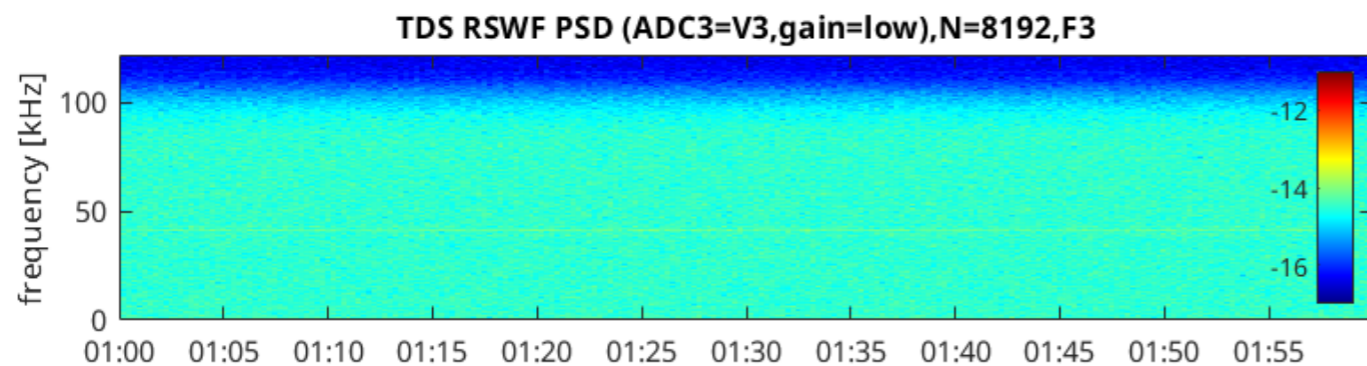
16-Dec-2023, 240 snapshots, dt = 15.0 sec

- ❑ Channel3 only sees (analog) noise, comparable to a situation when the preamplifier would be grounded at its input.
- ❑ Even the 120 kHz interference from the PCDU is gone.
