RPW ANOMALY REVIEW BOARD

April 26, 2024

RPW antenna 3 anomaly (2023-11-13)

Solo RPW Antenna 3 Issue

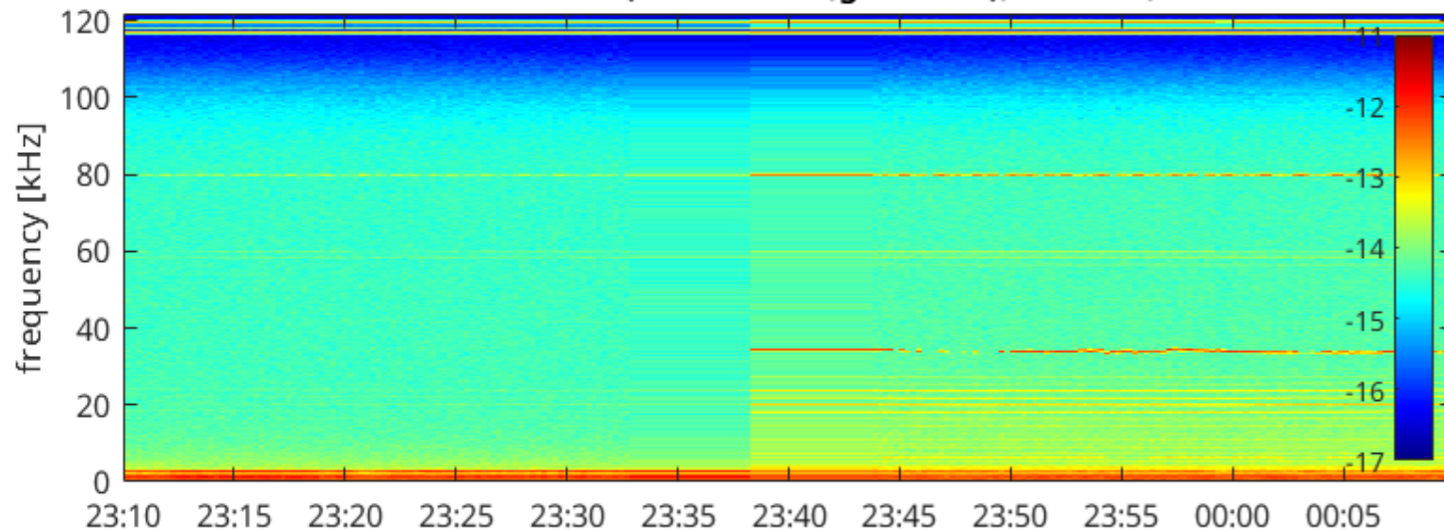
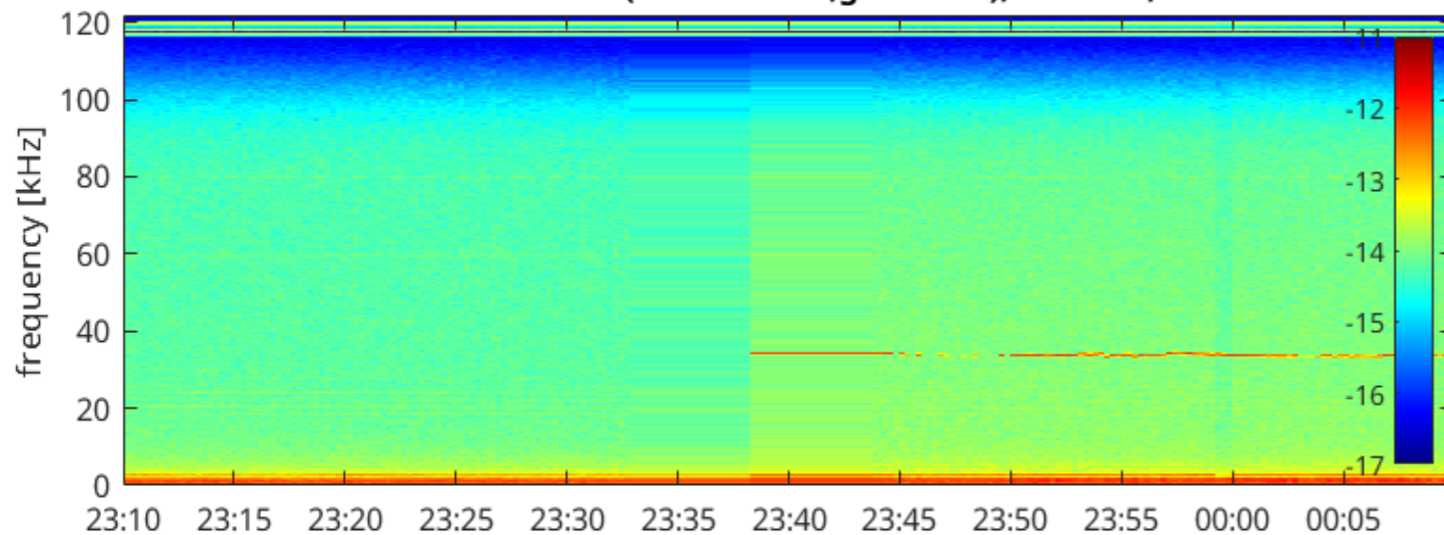
13-Nov-2023, 198 snapshots, dt = 15.0 sec

- ❑ V3 anomaly occurred on Nov 13, 23:38.
- ❑ TDS was in a dipole configuration
- ❑ Channel 1 (V1-V3) observes an increase in background interferences due to changing from a dipole to effective monopole
- ❑ Increase of the 40 kHz interference observed on both channels, this is common after a BIAS current change.
- ❑ A slight increase of background noise on V2-V1 channel observed too. Origin unknown, may or may be related to the anomaly or a bias current change.

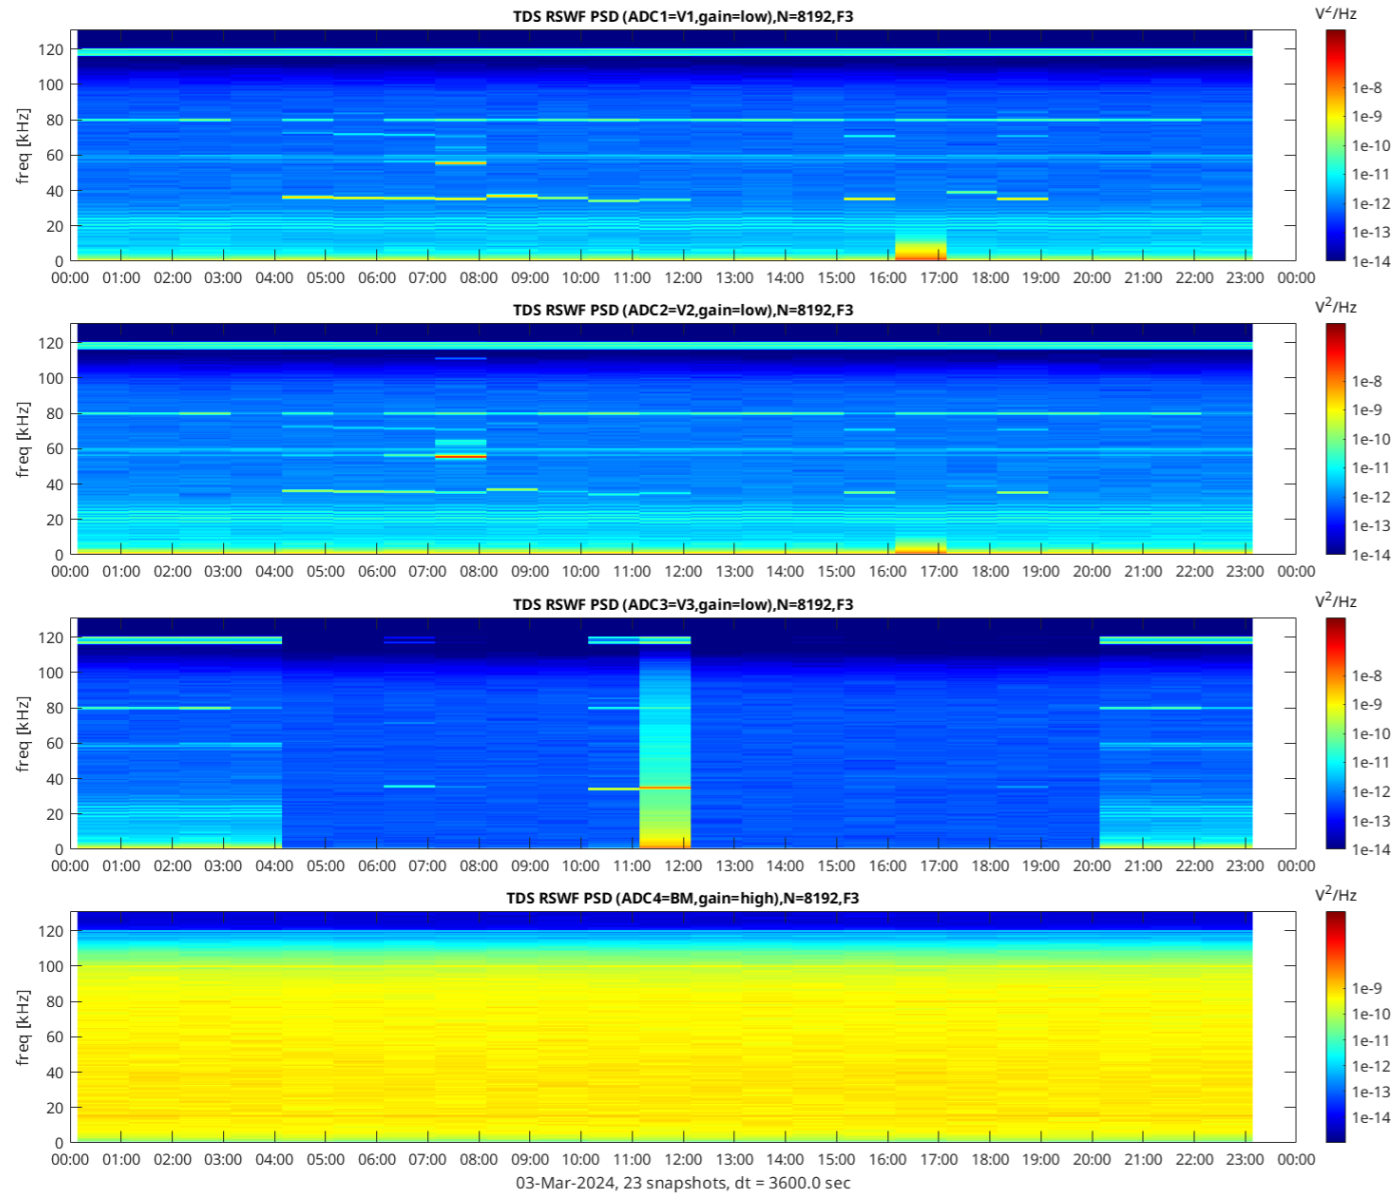
TDS data – March 3, intermittent V3 loss

- ❑ After recovery of V3, the signal has been lost again temporarily on the 3rd of March.
- ❑ Regular snapshots, only 1 hour resolution available
- ❑ Intermittent loss of signal with a short recovery around mid-day.
- ❑ There are snapshots where some high frequency signal is still observed, but attenuated (looks like a capacitive short).

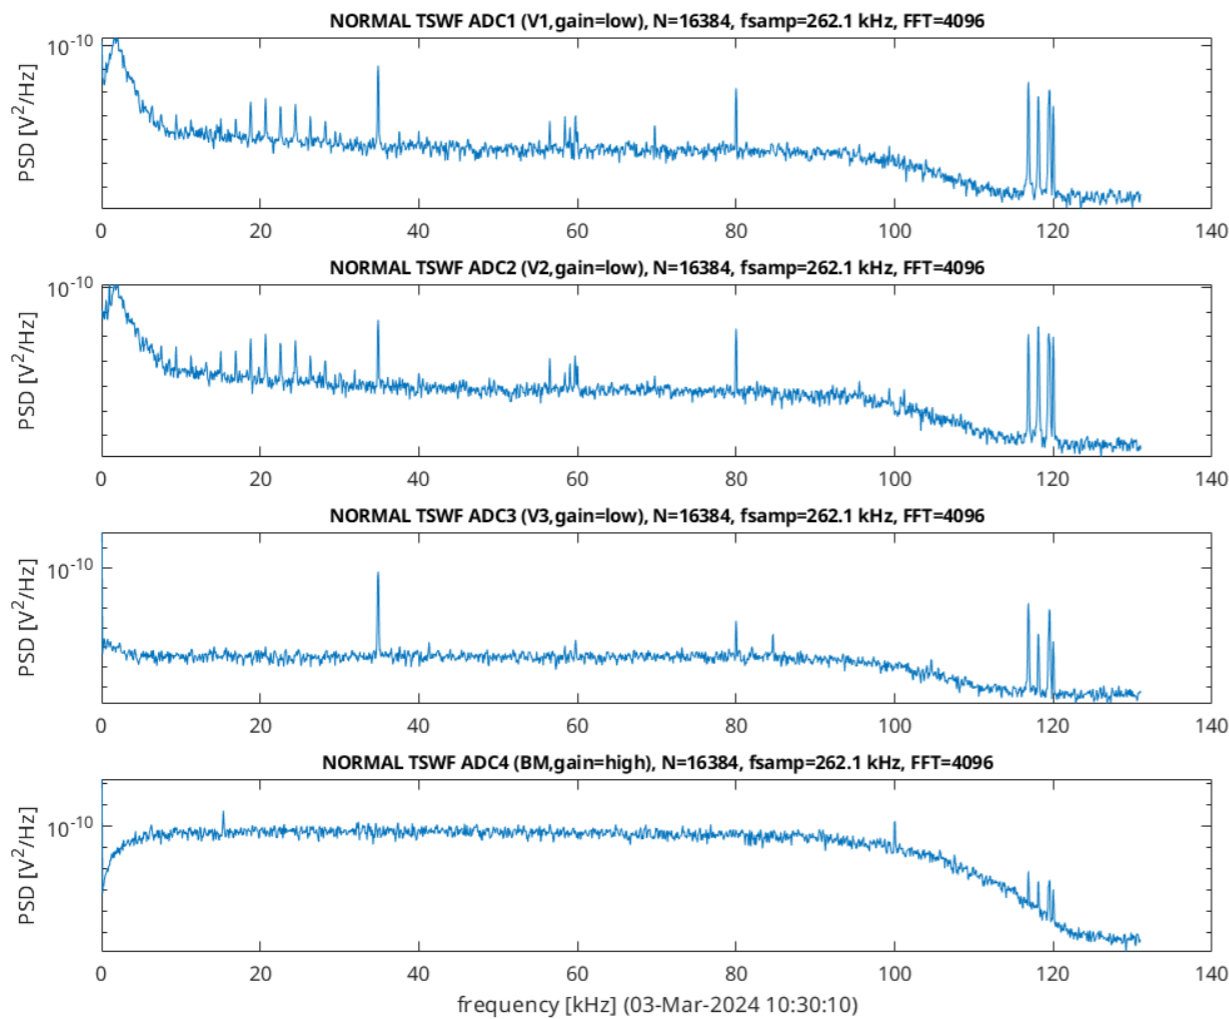
Example of the “partial” anomaly on March 3

- No low frequency signal
- Attenuated 120 kHz and other interferences
- Some (real science) signal at 35 kHz observed, probably with attenuation.

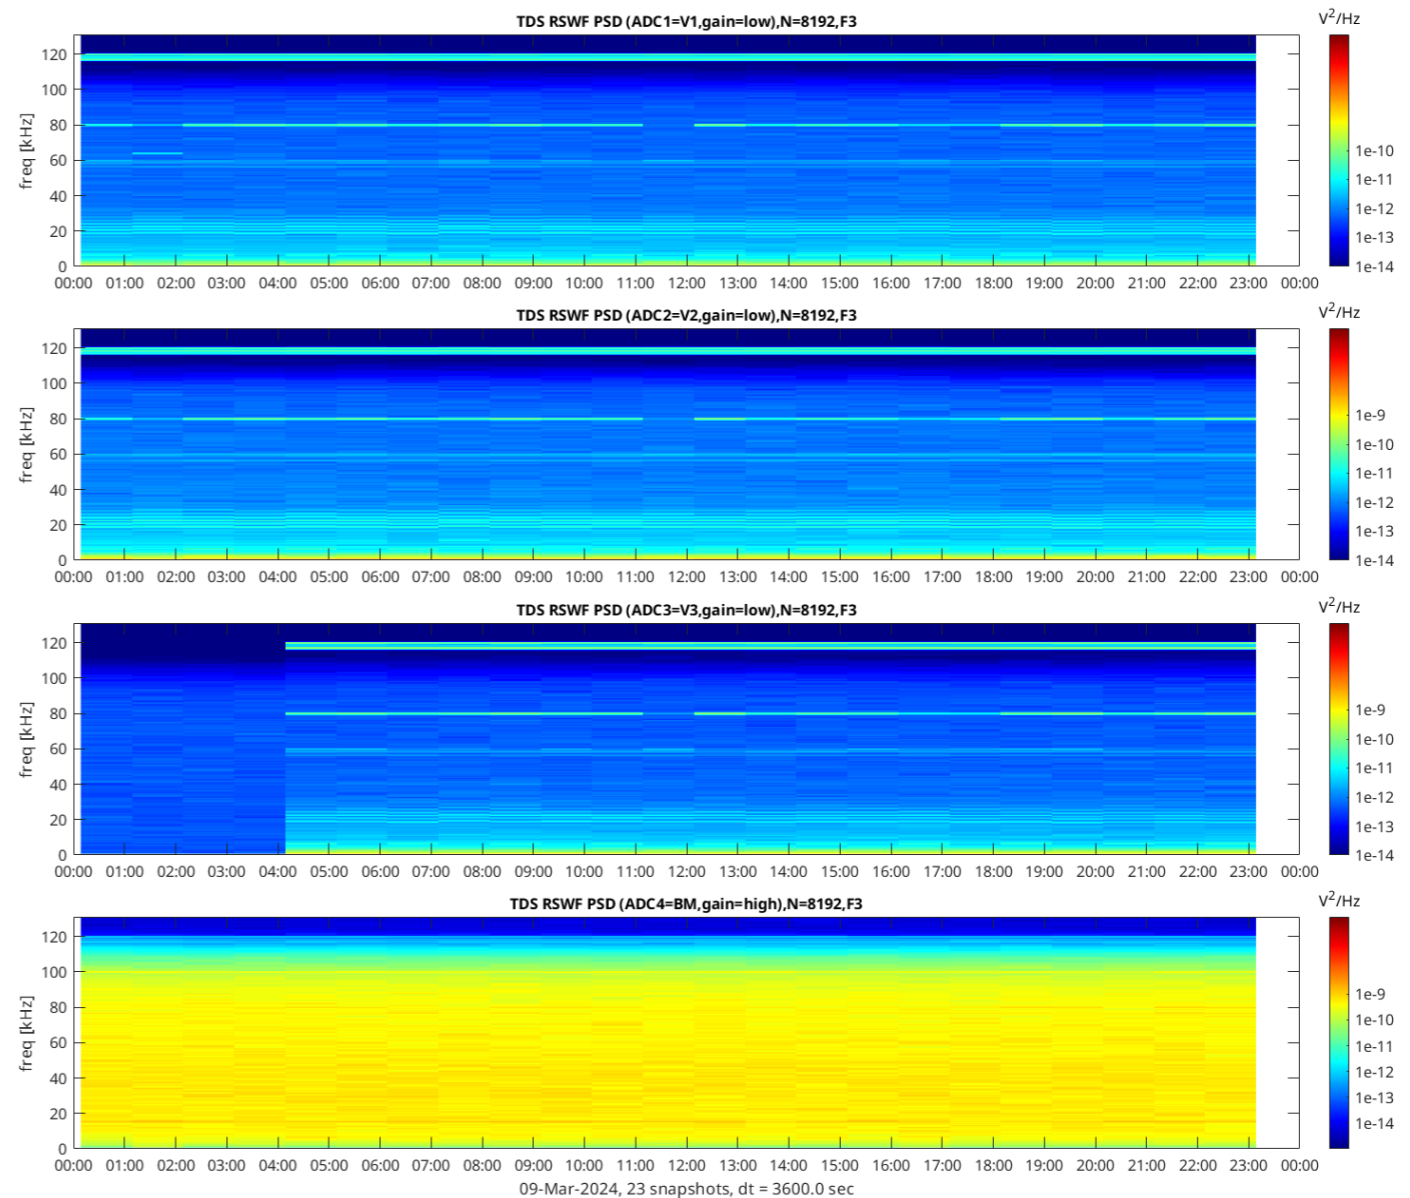
TDS data: Example of loss of signal after a BIAS sweep

- ❑ Regular snapshots, only 1 hour resolution available
- ❑ Signal lost again for a few hours on March 9 after the BIAS sweep.
- ❑ This pattern has repeated several times in March until the sweeps have been stopped.
