RPW Consortium Meeting #23

EMC Tests status

30/09 & 01/10 2019,
Meudon

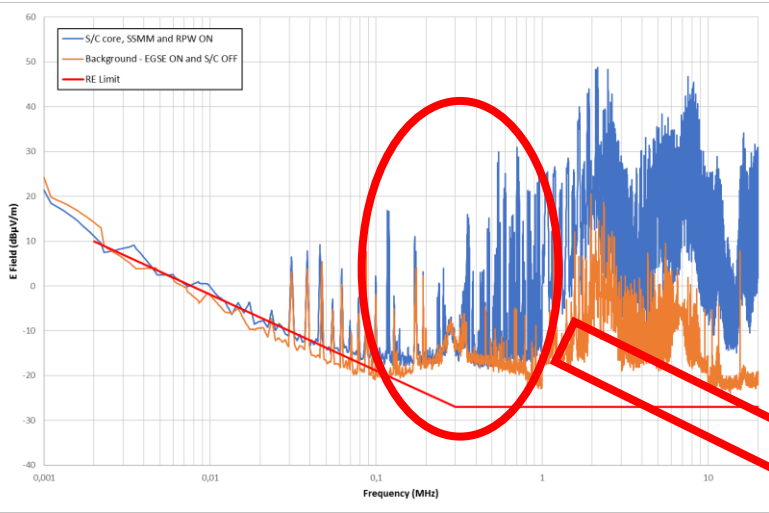
Background measurement

- Noisy background due to APR converters (120kHz) and its harmonics

Spikes amplified by EGSE cable, should not be seen during flight

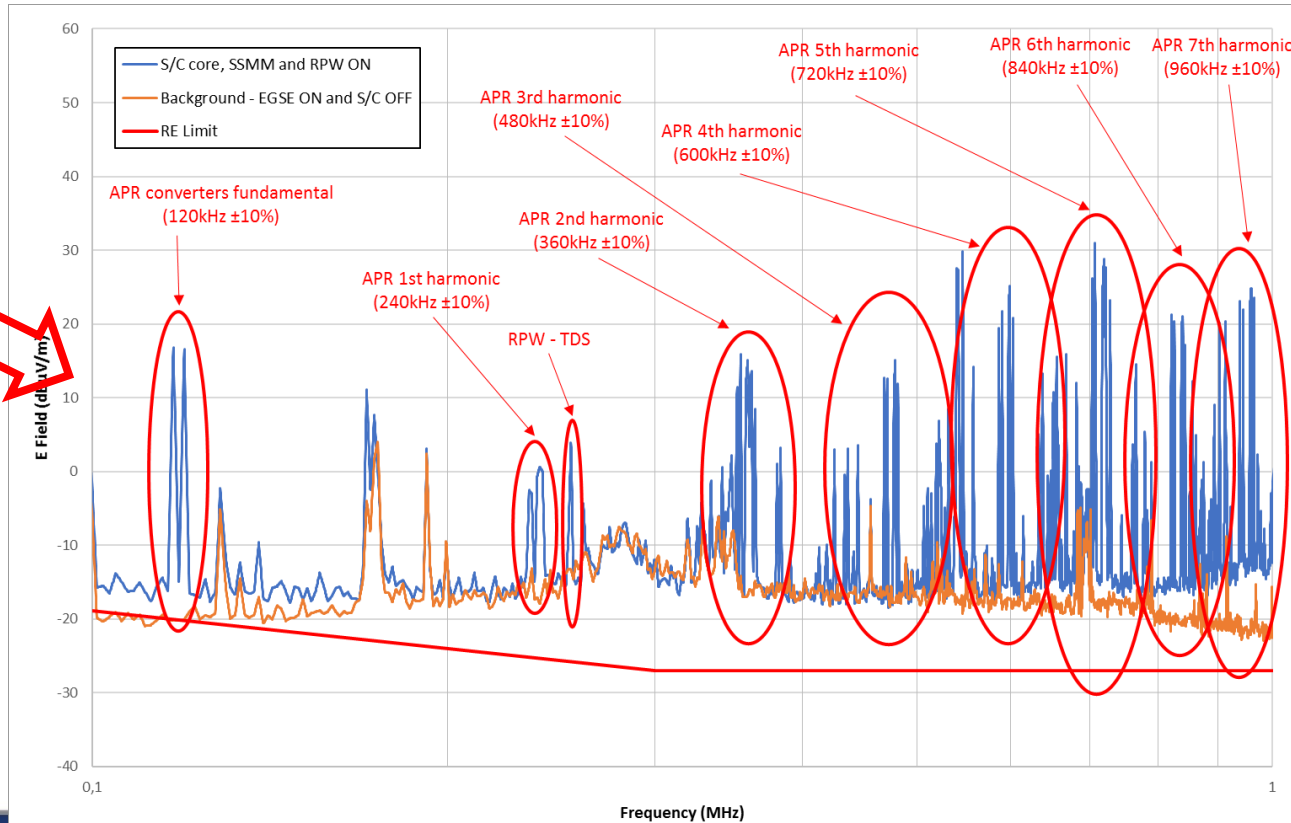
Main contributors seen with ARA antenna

Unit	Components / Function	Frequency	Level over background
PCDU	APR converters	120kHz + harmonics	5 to 40dB
RW + WDE	DC-DC converter	80kHz + harmonics	5 to 15dB
SADE	AD conversion rate, burst	23.81kHz	2dB
METIS	DC-DC switching frequency	130k – 140kHz	3dB

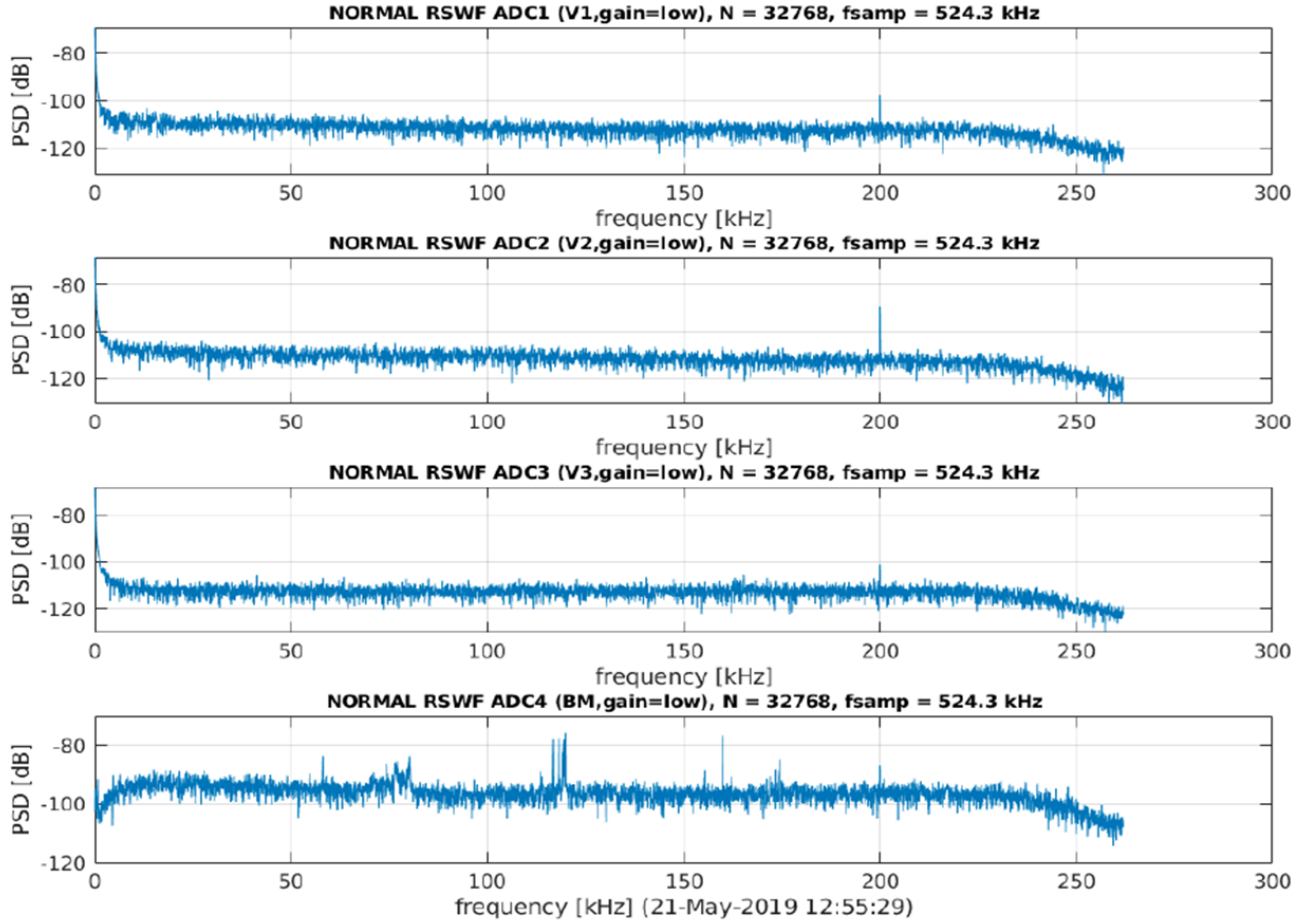
E-field above 1kHz

Only the RPW internal interference at 200 kHz (BIAS DC/DC)

Otherwise, E-field is very clean at high frequencies.

Noise floor unchanged since calibration.

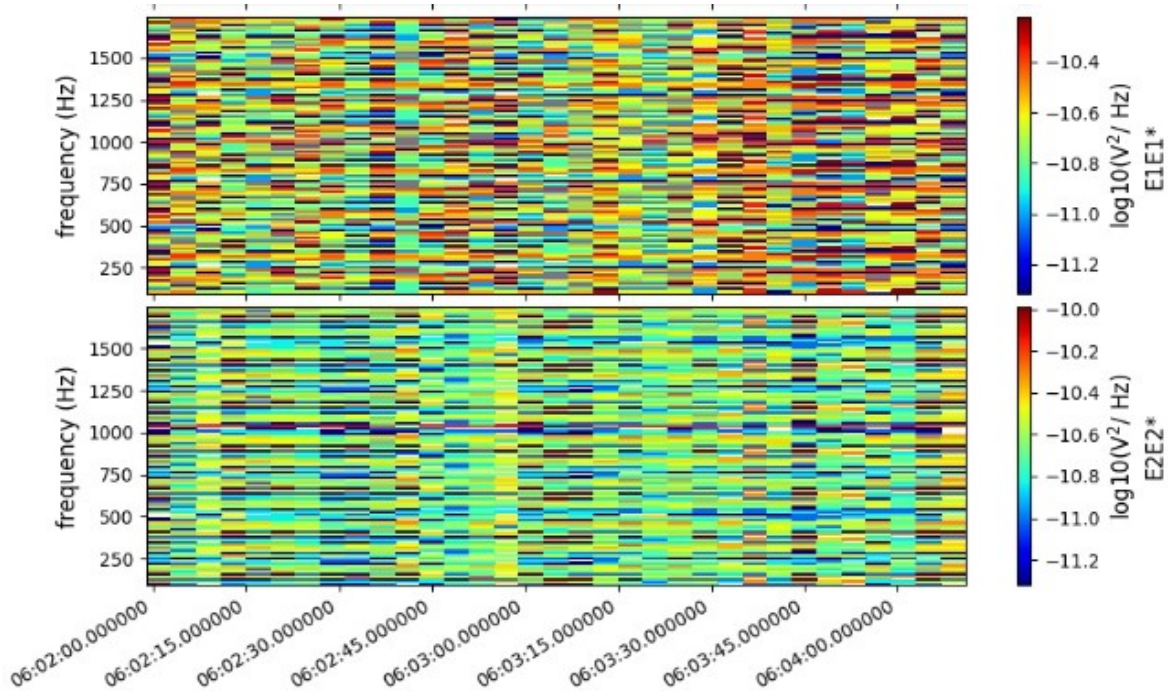
E-field

- **LFR spectral products** : In electric we see the sensitivity level of the LFR
- There are no electric counterpart of the radiated magnetic 50 Hz. This is very suspicious !
- Also the LFR team discovered BIAS is possibly in calibration mode (need to recheck the ROC pipeline). Were the electric antennas really connected ?

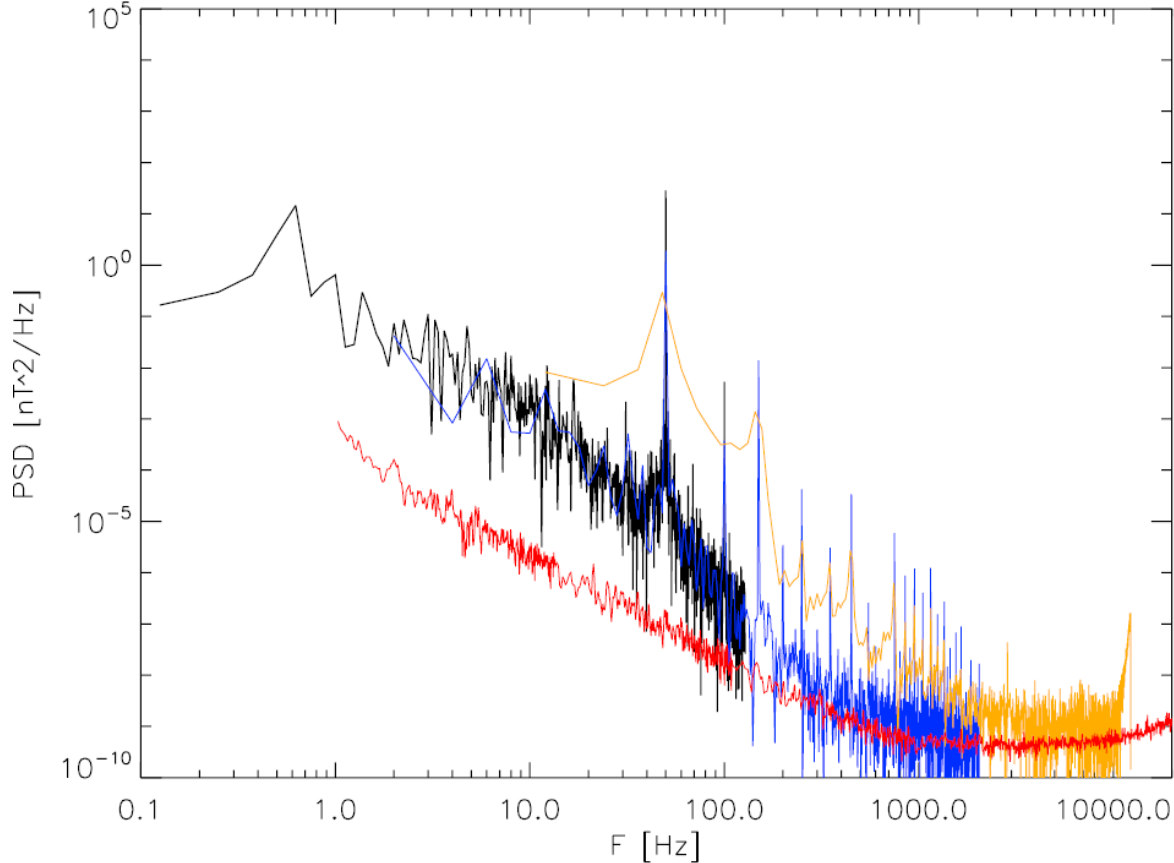
LF3X 20190522 15:43:48.9993

- **Black, blue & orange are spectra obtained in the IABG chamber @ f2, f1 et f0 LFR filters**
- **Red is the SCM requirement**
 - **No reaction wheels**
 - **Strong 50 Hz perturbation and harmonics**
 - **The EMC chamber background is about 20 dB above the RPW requirement below 200 Hz**

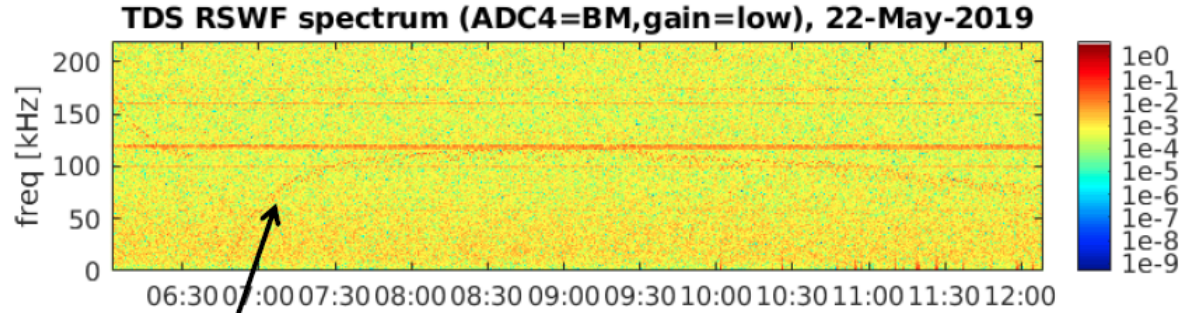
B-field above 1kHz

There is a number of spikes in HF magnetic field, but the amplitude is reasonable (max 15 dB above noise).

Noise floor same as during calibration.

Drifting spike. Moves in frequency, present most of the time.

100 kHz (not there on May 21)

EGSE (~120 kHz). All the time

Constant 160 kHz. Started on 21/5 12:15 UT

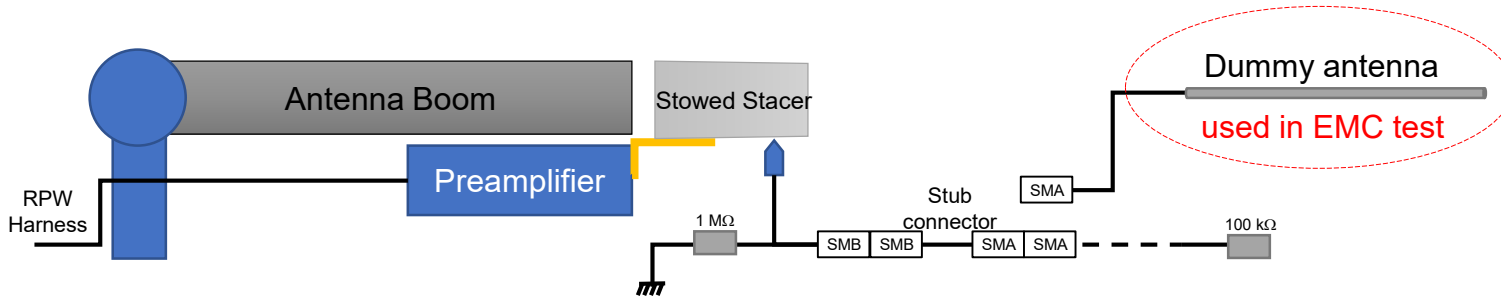
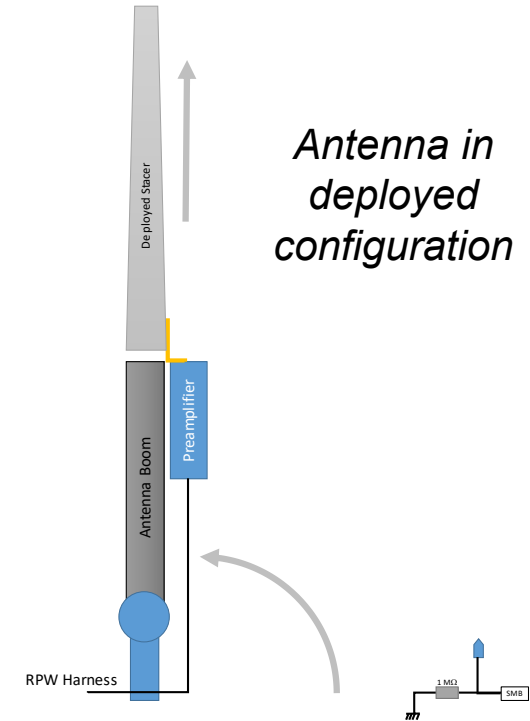
Connection Issue on PY/V2 antenna 1/3

- A connection issue is suspected on PY/V2 antenna.

Antenna in stowed configuration

- ✓ Hardware issue at MEB level,
- ✓ Connection issue at RPW harness level (i.e. between MEB and PY antenna PA),
- ✓ Unexpected path to ground from the stacer (i.e. potential interference with MLI)
- ✓ Hardware issue at Pre-amplifier level
- ✓ Connection issue at PY antenna internal connections level (between PA input, antenna stacer, grounding pin until the SMB connector).

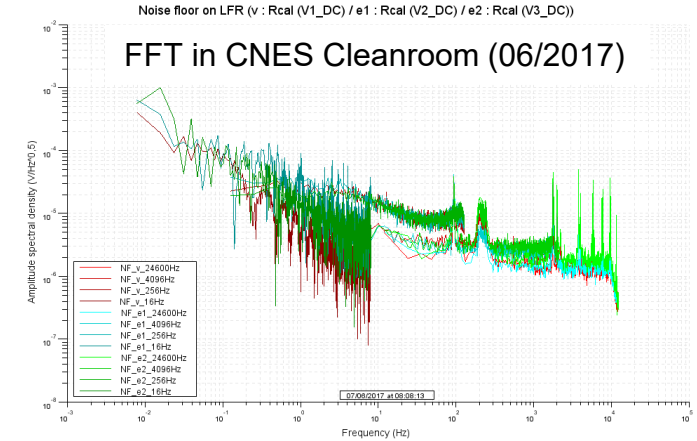
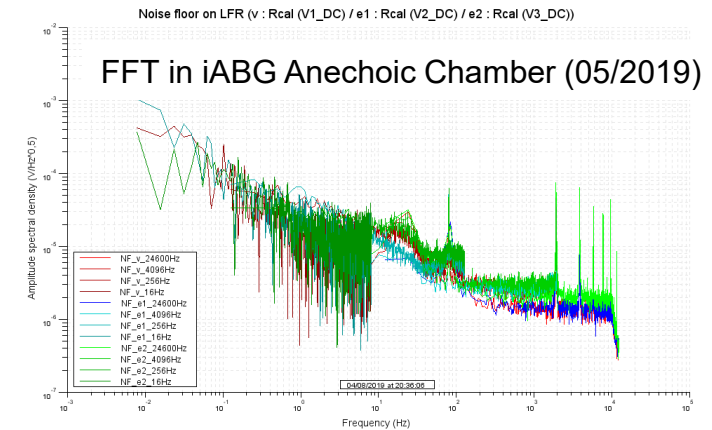
Connection Issue on PY/V2 antenna 2/3

- Further analysis shows that the internal connections until preamplifier are not in cause (i.e. MEB, RPW harness between MEB and PY antenna preamplifier).
- Indeed on test #40, the NF on LFR performed when antenna PAs are on the internal R_cal load give similar results for the three antenna PAs. This confirms that the electrical paths until R_cal are ok.
→ No HW or connection issue between MEB and Preamplifier

→ Similar results are obtained during both FFTs

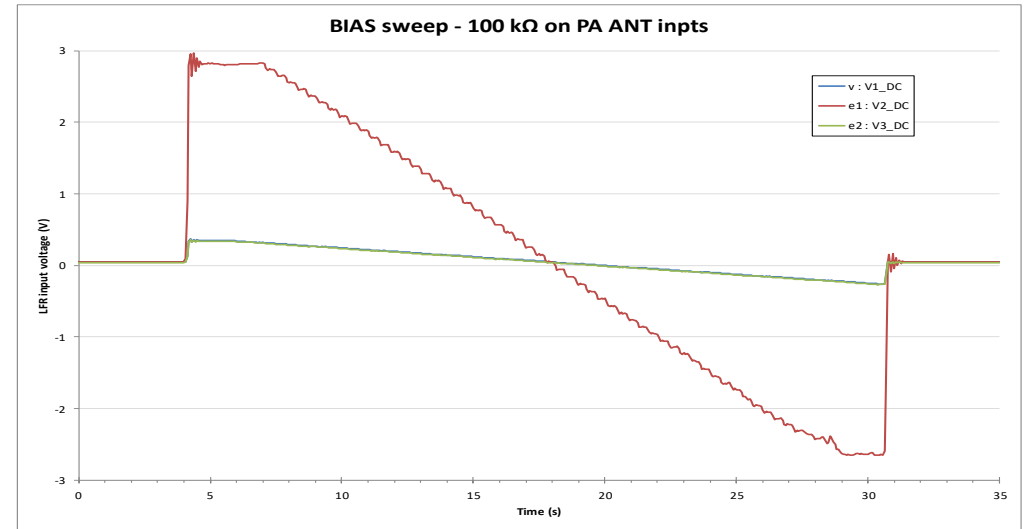
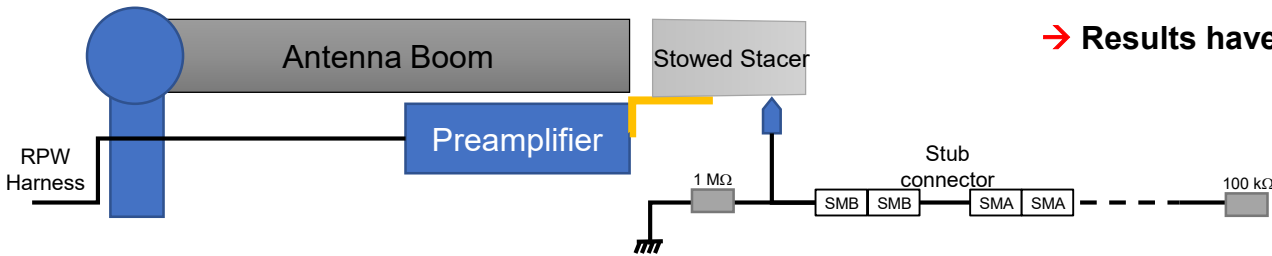
Connection Issue on PY/V2 antenna 3/3

- Moreover, BIAS sweeps show that the PY/V2 antenna impedance is 10x higher than for the two other antennas (connected to a 100 kOhms load). Then the V2 antenna would be loaded by ~1MOhms.

This load corresponds to the case where no additional load is connected to the SMB connector (floating case) and confirm the integrity of the internal PY/V2 antenna connections until this point.

→ No connection issue between MEB and grounding pin/ 1 Mohms load

→ Results have been confirmed by BIAS team (email on the 05/09/19)
