RPW Consortium Meeting #23 – RPW General Status

E. Lorfèvre - September 30th 2019

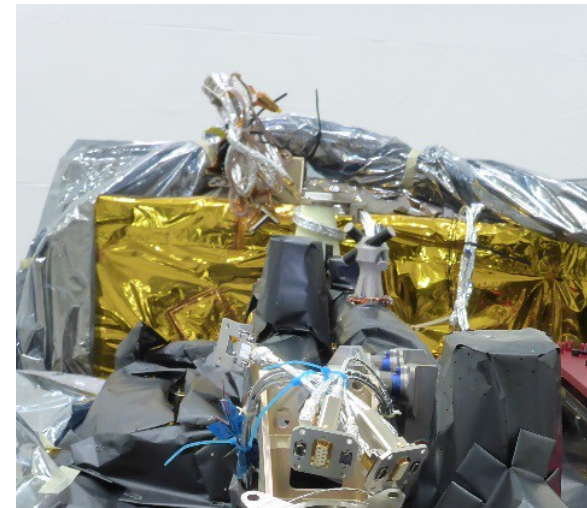
ANTENNAS

- **3 RPW antennas delivered on 28/06/18**
 - PY & MY antennas installed on S/C end of July 2018 (before TVAC)
 - PZ antenna installed on the satellite early January 19 (after TVAC)
- A post-mechanical test inspection has been performed last week
- From last year:
 - 11 damages on the antennas heatshields have been observed leading to 1 replacement early January 19,
 - 2 tears on the PY and PZ hinge MLI, replaced in January and September 19
 - PY & MY hinge micro-switches bent
 - RPW PY antenna boom mark and MLI punctures

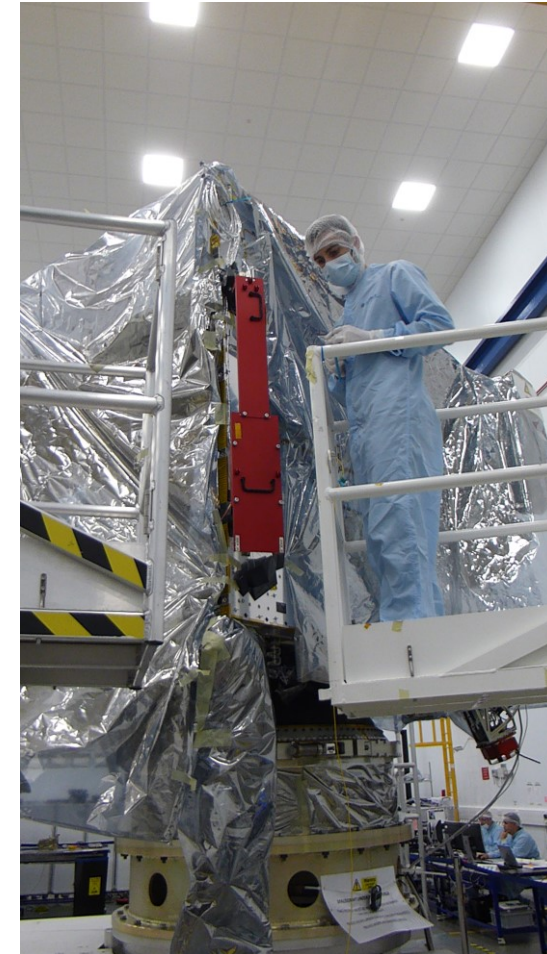
OSR Yoke Reflections onto PY & MY Antennas 1/2

- Yoke OSR reflections impact RPW Black Kapton MLI and PA radiator (>0.9 AU)
- Current thermal impact investigation focus on MLI impact
- The combined impact of thruster activation is considered

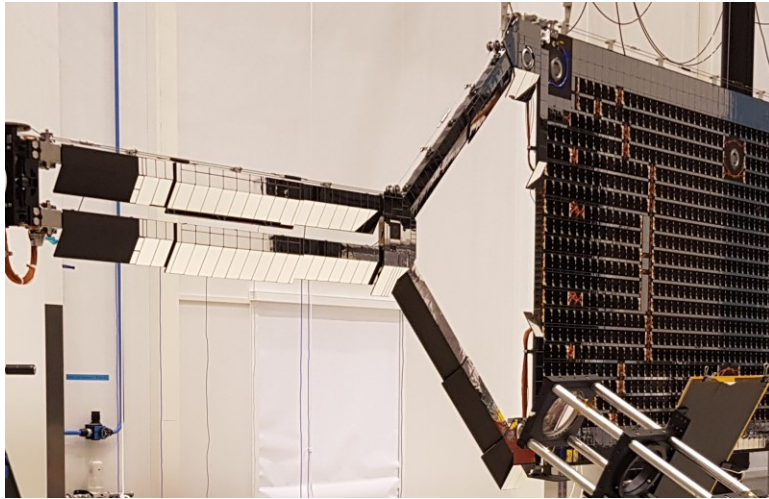
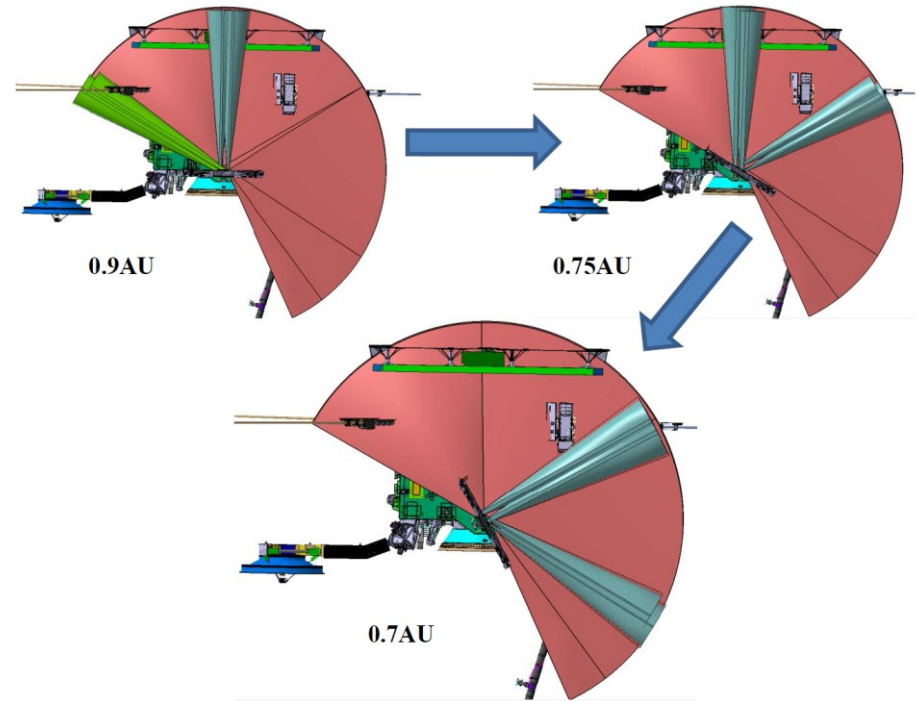
OSR Yoke Reflections onto PY & MY Antennas 2/2

- **Edge and Boom could experience up to 324°C (6136 W/m²)**
 - Y966 effective adhesive areas of edging are located on oriented surfaces
 - Boom coating degradation ⇔ Antenna performances degradation
- **MLI Cone confined : low view factor toward the space → High temperature could be reached**
- **RPW MLI worst case : 301°C**
- **Thruster impact: +21°C on lateral surfaces, +27°C on rear surfaces**
- **Estimation of temperature with different coatings**

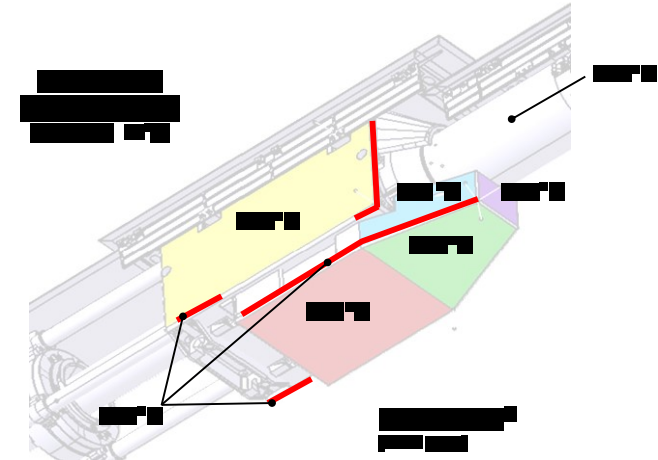
Black Kapton	Germanium	GCC
Front orientation	324°C	281°C	201°C
RPW MLI	301°C	261°C	187°C
