# RPW Antenna 3 Nov. 13, 2023, Operation Anomaly Report

Ref: ROC-OPS-NMP-RPT-00158-LES  
Issue: 01  
Revision: 00  
Date: 23/04/2024

This document presents the operation report concerning the RPW electrical antenna 3 (ANT3) anomaly, first observed on-board on November 13, 2023 around 23:36z.

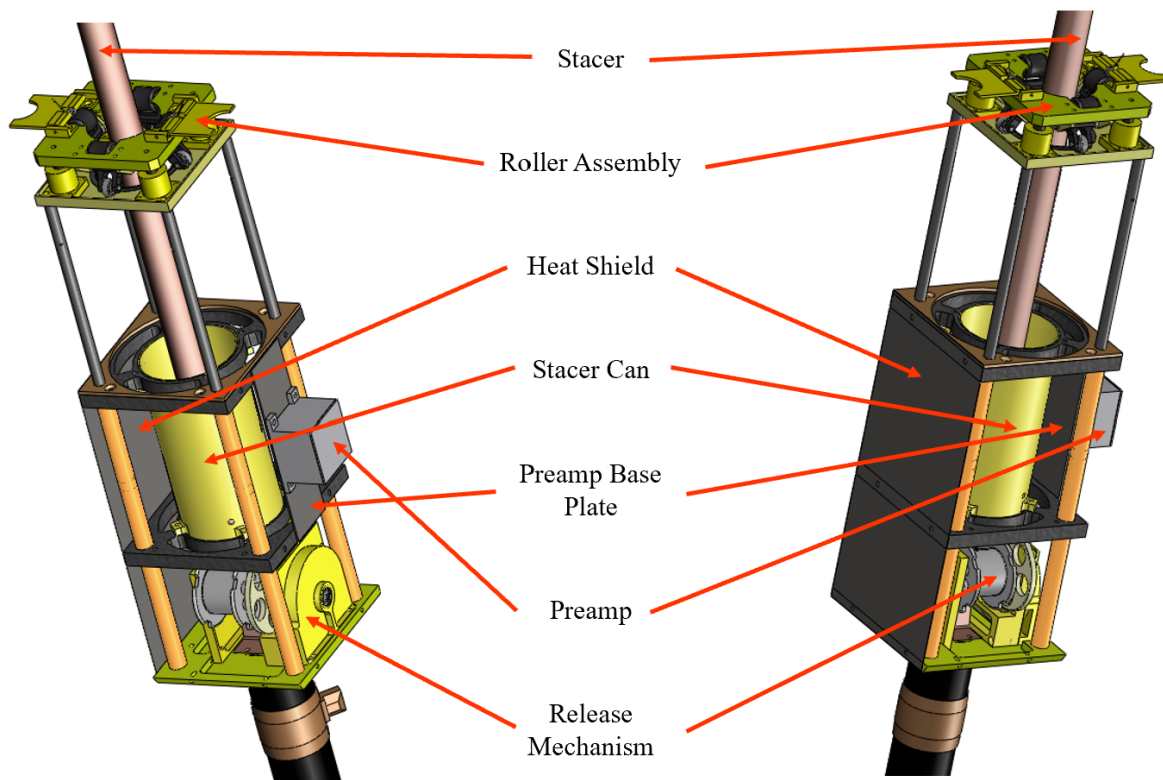
Figure 16. RPW antenna preamplifier and deployment mechanism model.

Current SolidWorks Model

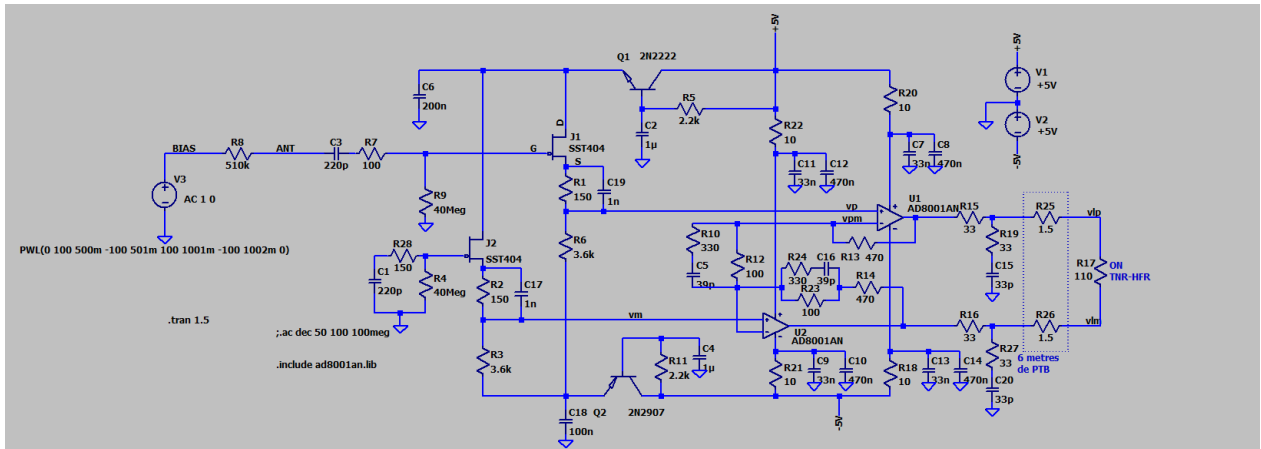
Figure 17. RPW HF PA model used for simulation.

3. The waveform at the output of the preamps (differential signal in blue) shows a relatively narrow and intense pulse. This coincides with the rising edge of the BIAS sweep, which has the effect of saturating the HF preamp for a short duration. This voltage pulse results in excess consumption in the 110 ohms load, which explains the current peaks observed on the monitoring HKs.

In addition, we observed that the HF preamps systematically and almost instantly return to normal consumption after the pulses transients (those caused by the rising edge of the BIAS sweep). This excludes the latch-up hypothesis.

Finally, when the short circuit disappeared and the ANT#3 recovers its function, the observables revealed no difference in behavior before and after the anomaly. If a preamp failure had occurred, it is very likely that its consequences would have been visible in scientific and monitoring data.

A simple failure on the link capacitor (C100) would even have propagated to the LF preamps and would have affected BIAS operation. A double breakdown is very hypothetical and would have been even more visible. However, this is not the case.
