# PA PHOTOS REPORT

## RPW ANTENNA 3 ANOMALY

ERIC LORFEVRE  
**11/07/24**

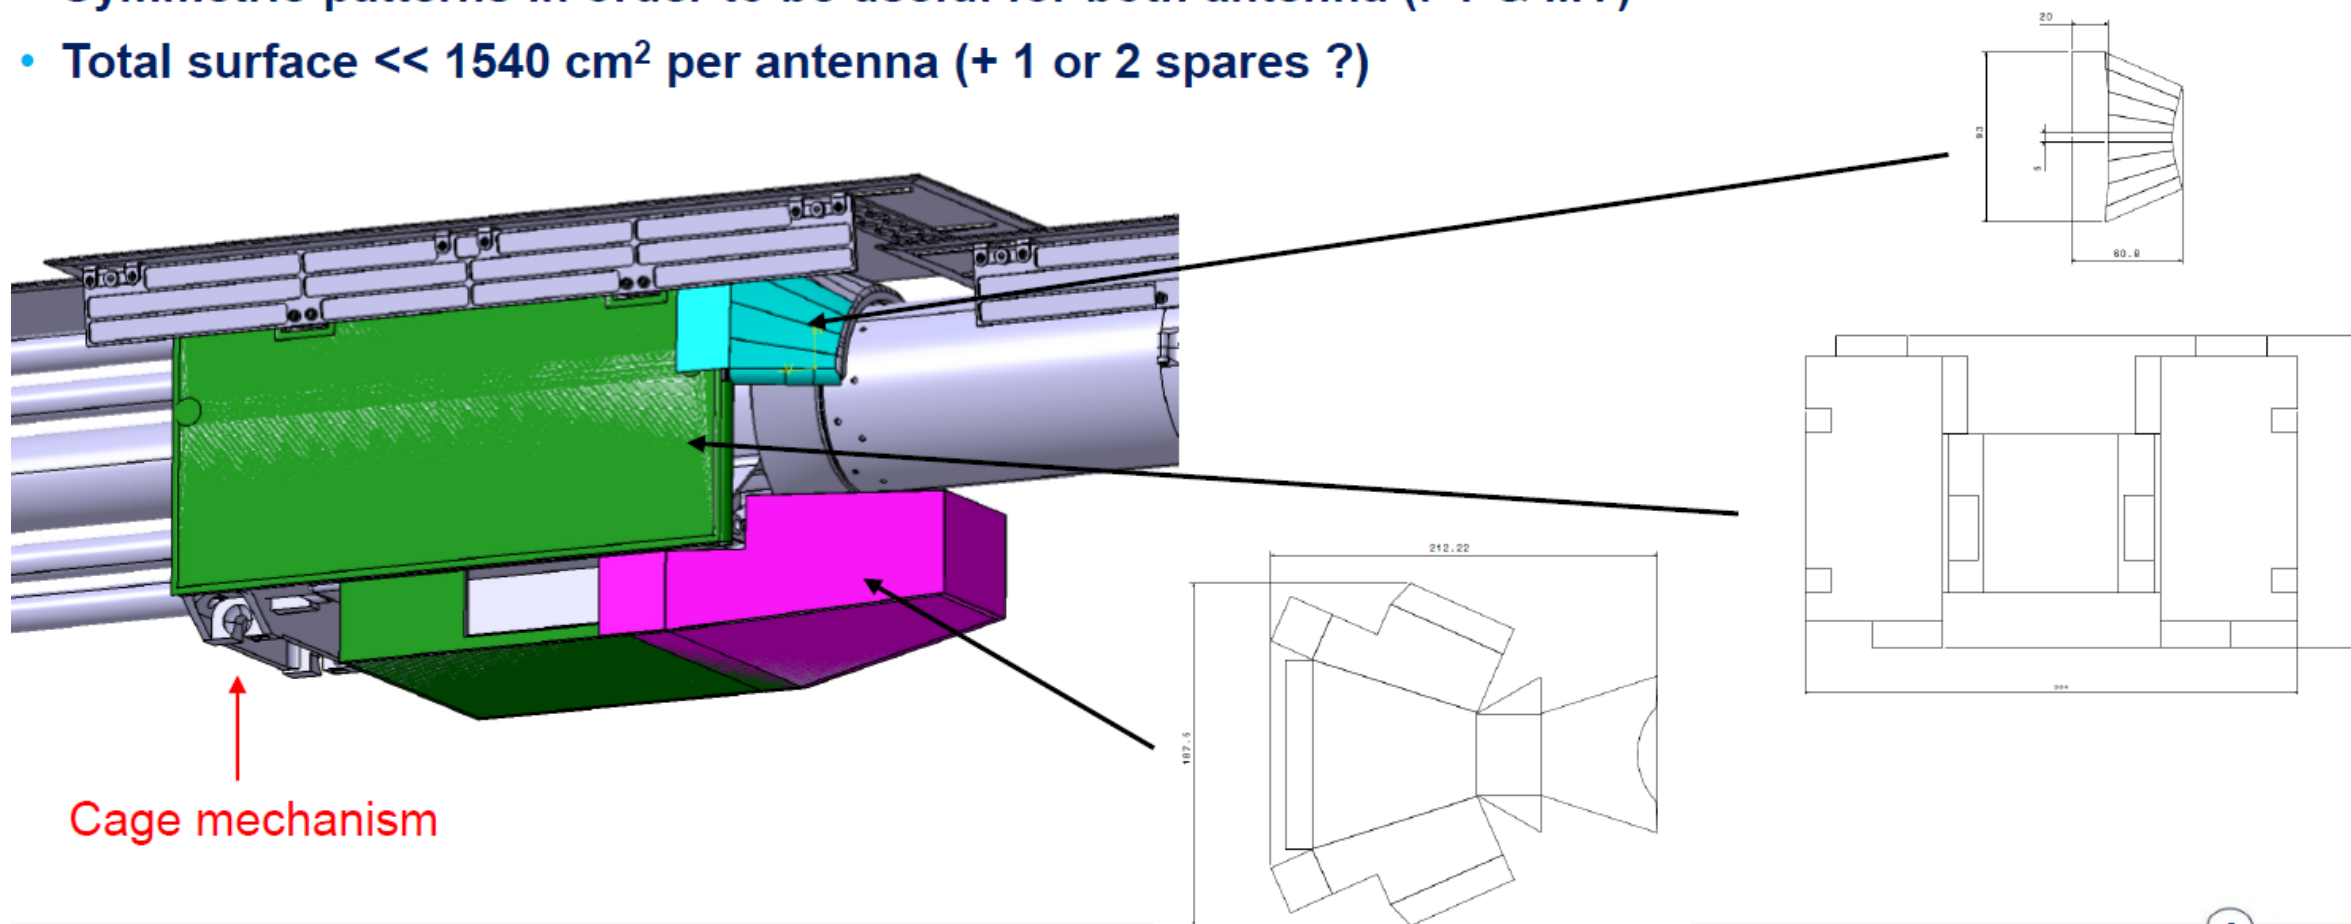
# SLI DESIGN

- Composed by 3 parts: stacer frame SLI (green), PA harness box (pink) and Cone protection (blue)
- Symmetric patterns in order to be useful for both antenna (PY & MY)
- Total surface  $\ll 1540 \text{ cm}^2$  per antenna (+ 1 or 2 spares ?)
