RPW ANOMALY REVIEW BOARD

April 26, 2024

RPW antenna 3 anomaly (2023-11-13)

Solo RPW Antenna 3 Issue

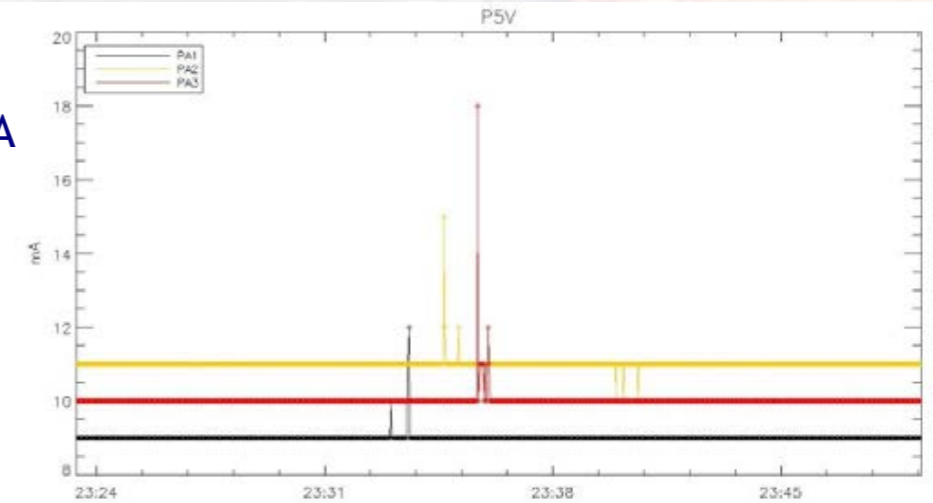
- Overconsumption peaks occurred at the time of the failure on the HF PA
- It was then found that these current peaks systematically appear during BIAS sweeps

- To understand the reason of these overconsumption peaks and their relation with BIAS sweeps
- To estimate the possible stress caused by these peaks on the preamps

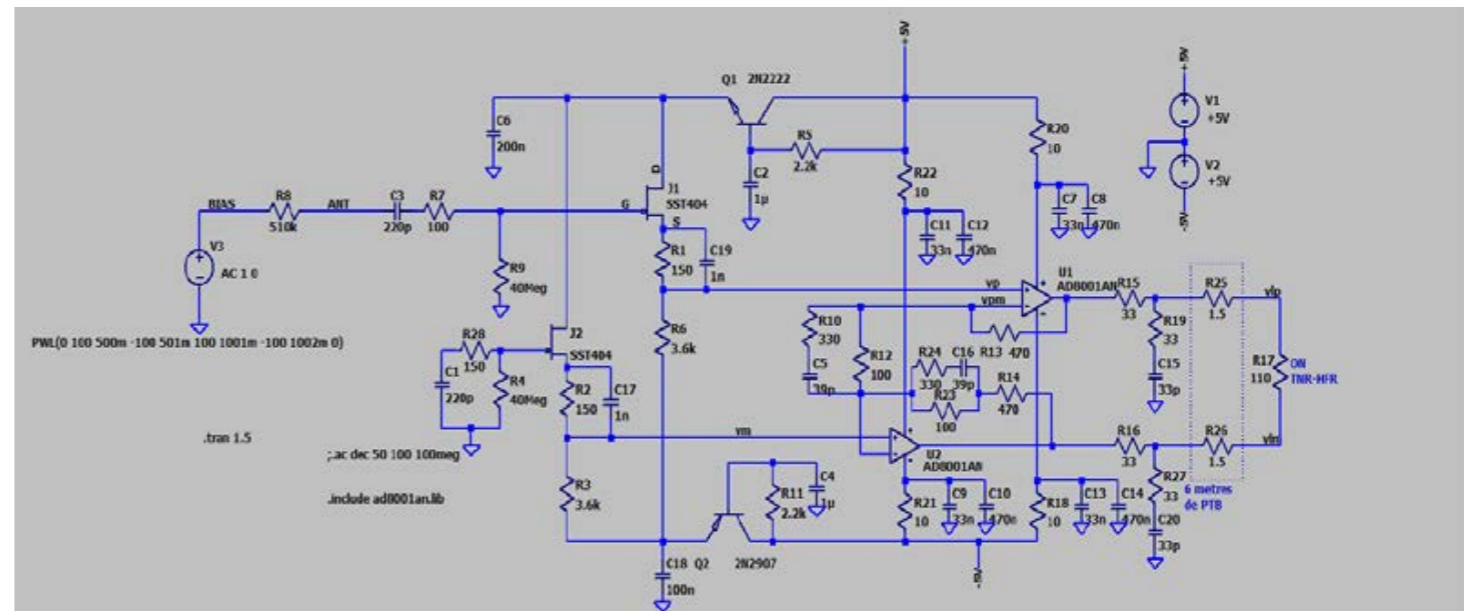
Modeling setup

- Model taking into account all the stages of the preamp and the output impedance of the BIAS current source
- Realistic configuration is for normal operation ... but not necessarily for the anomaly
- Large ramp of +/-100V to simulate the BIAS sweeps → Extreme worse case conditions
