RPW Consortium Meeting #23

EMC Tests status

30/09 & 01/10 2019,
Meudon

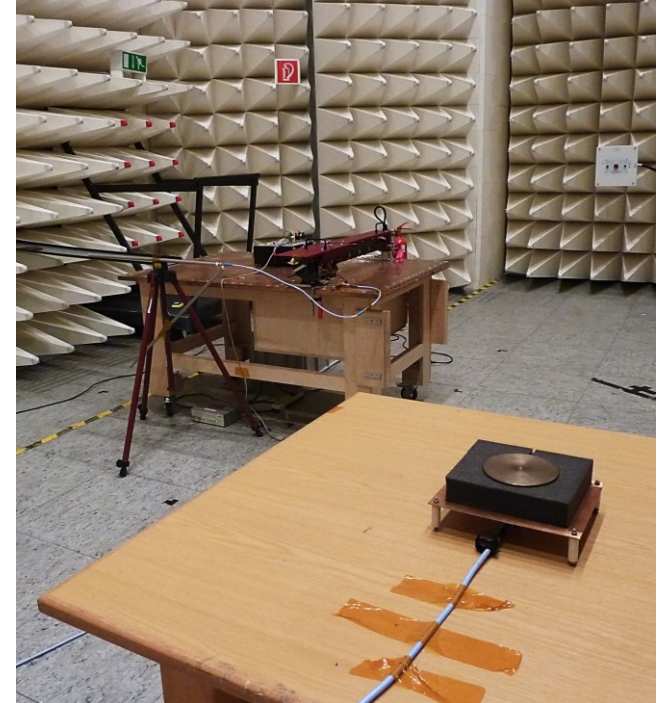
RPW + dummy antenna calibration (April 2019)

- **Calibration to evaluate dummy antenna gain when connected to RPW antenna**
 - S21 calibration antenna / RPW QM antenna (with and without dummy)
- **Scan E-field to assess empty EMC chamber background**
 - RPW QM antenna (with and without dummy)
 - ARA antenna
- **Scan B-field to assess empty EMC chamber background**
 - Search coils

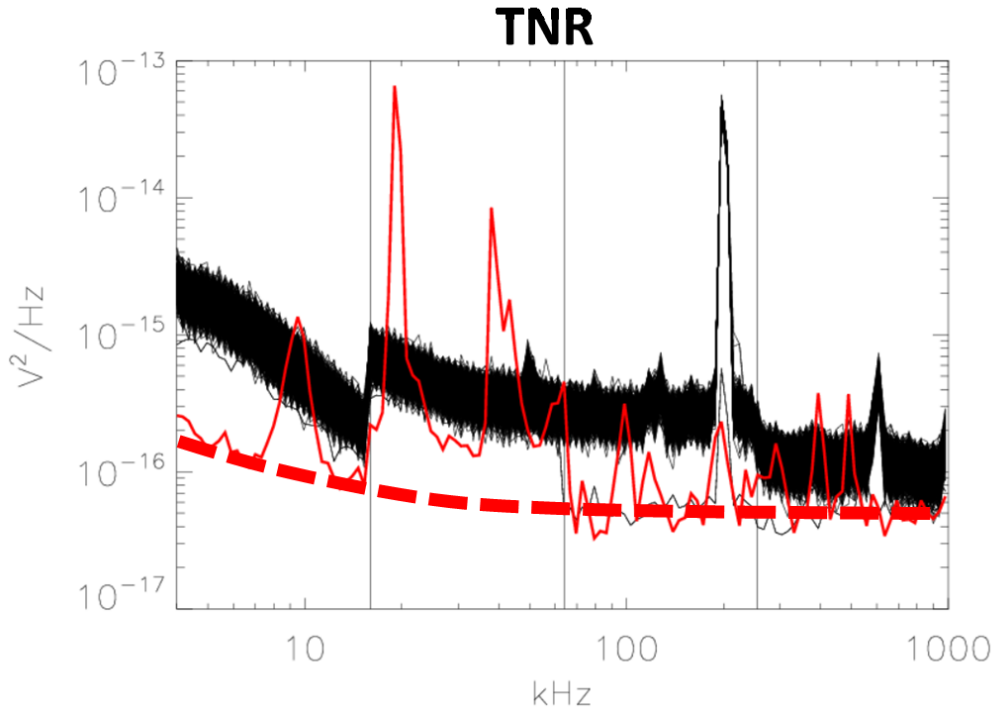
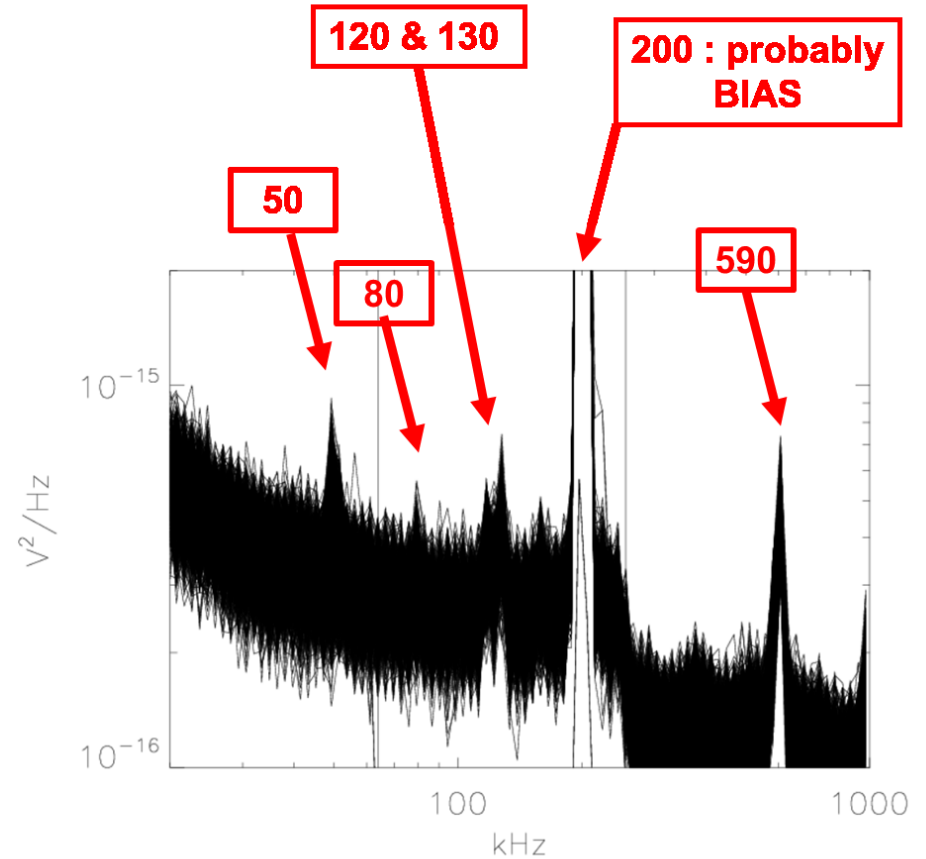
Electric field measurement

All spectra for V1 between
06:00:10.597971 & 17:50:16.846937
on 22 May 2019

Detected spurious frequencies (kHz) for each sensor

V1	V2	V3
	715	715
590	550	550
200	200	200
130	160	160
120	120	120
80	80	80
50	60	60
	40	40
	7

V3 seems the same perturbations as V2. How is this possible ?

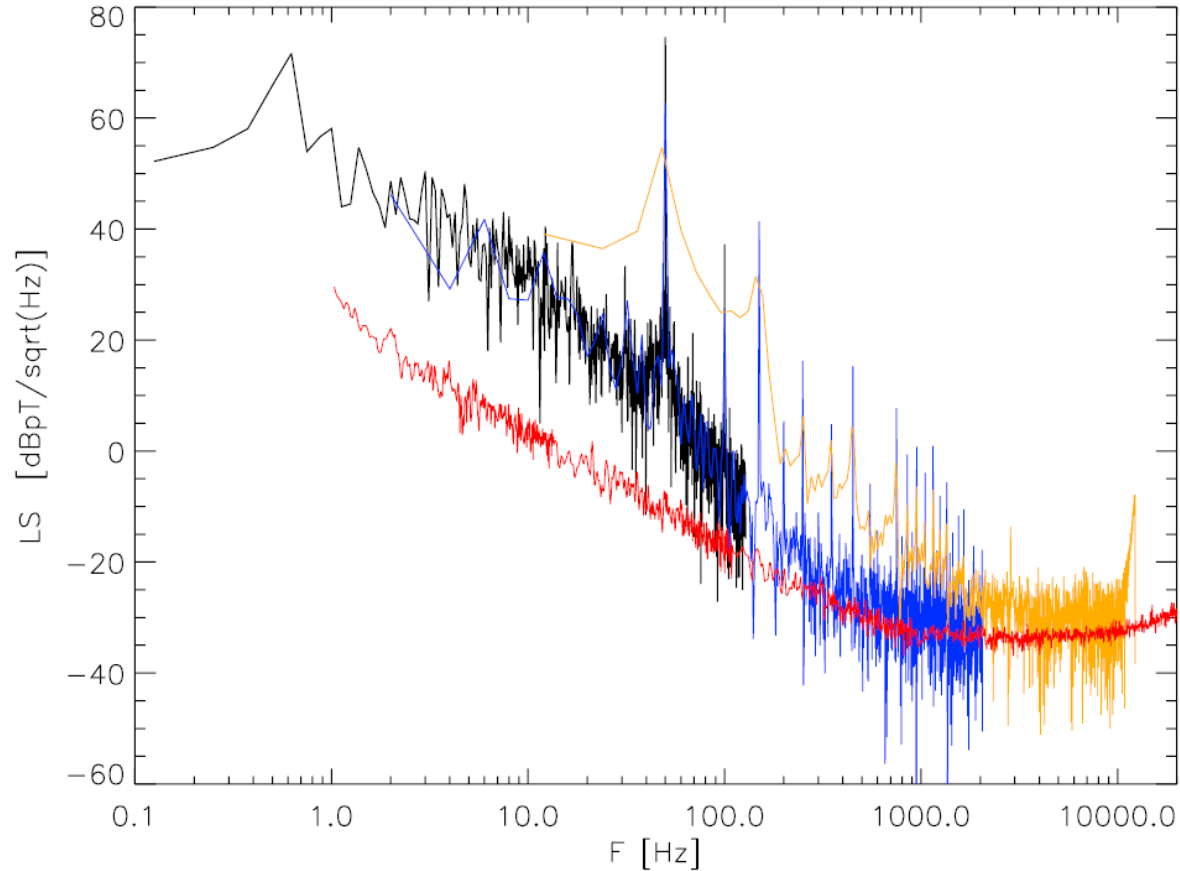
Magnetic field measurement

- Same in dBpT/sqrt(Hz) for comparison with the ADS report

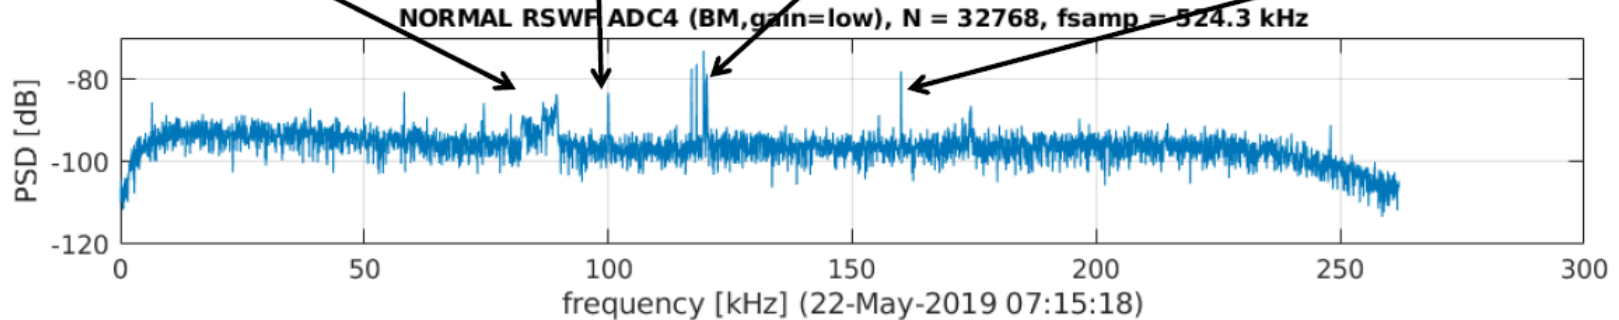
Drifting spike. Moves in frequency, present most of the time.

100 kHz (not there on May 21)

EGSE (~120 kHz). All the time

Constant 160 kHz. Started on 21/5 12:15 UT

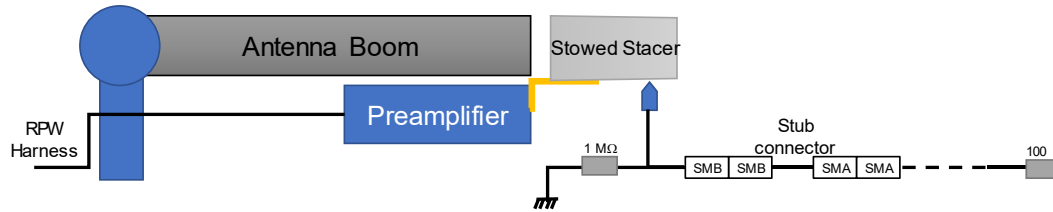
Connection Issue on PY/V2 antenna 2/3

- Further analysis shows that the internal connections until preamplifier are not in cause (i.e. MEB, RPW harness between MEB and PY antenna preamplifier).
- Indeed on test #40, the NF on LFR performed when antenna PAs are on the internal R_cal load give similar results for the three antenna PAs. This confirms that the electrical paths until R_cal are ok.
→ No HW or connection issue between MEB and Preamplifier

→ Similar results are obtained during both FFTs
